SUBJECT: Annual Mitigation Monitoring Report for Off-site Mitigation for: USCOE Permit # NWP-2006-943 DSL Permit # 37571-RF Project Name: North Fork Siuslaw River Bridge Replacement (Hwy 126 MP 0.8-1.51) Lane County, Oregon (ODOT Key # 11791)

Permit Number <u>37571-RF (Off-site Mitigation ONLY)</u> Monitoring Year <u>Year 7 of 15 yrs required (2014)</u> County Lane ODOT Key # <u>11791</u> Authors Laura Brophy, Laura Brown

Annual Compensatory Wetland Mitigation Monitoring Report for 2014 (Year 7) Off-site Mitigation, North Fork Siuslaw River Bridge Project

## Compensatory Wetland Mitigation Monitoring Report Off-site Mitigation, North Fork Siuslaw River Bridge Project

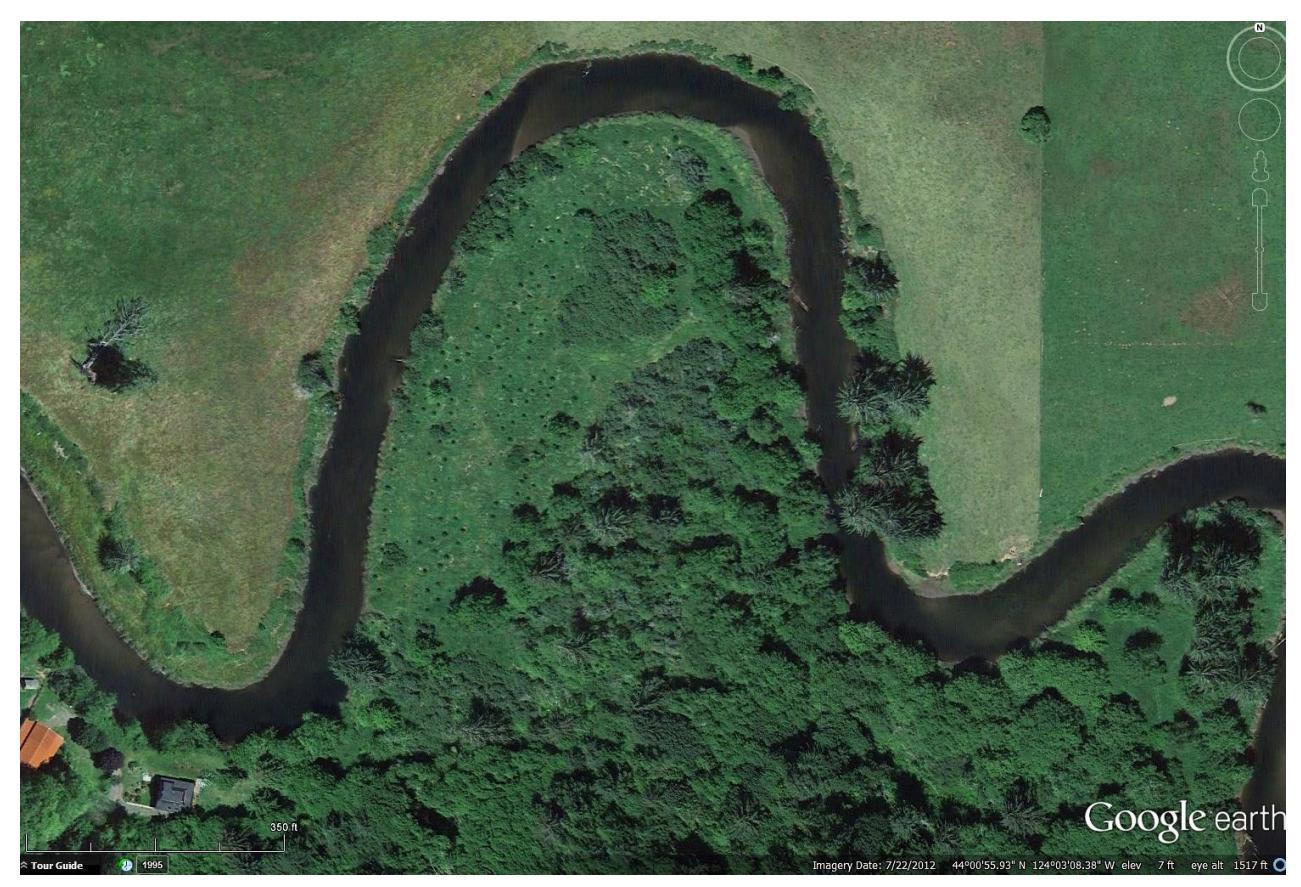
Google Earth imagery of mitigation site (imagery date: 7/22/12). Over 100 planted Sitka spruce can be seen within the restored area (dark dots in grassy former pasture).

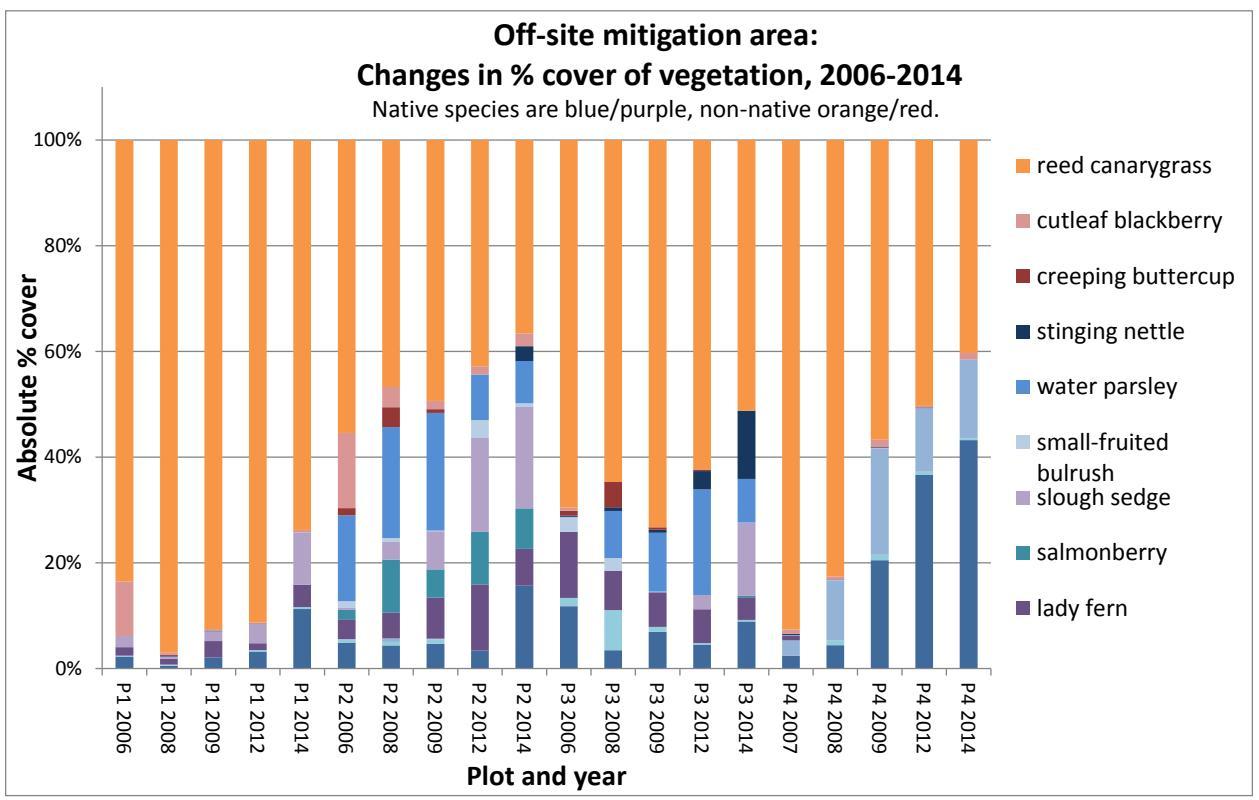
**Benchmark 2 (MET)** states that percent cover of reed canarygrass must show a significant decrease by 2012, and this trend must continue through 2022. As described in Brophy (2012), percent cover of reed canarygrass decreased significantly from 2006 to 2012. Between 2012 and 2014, cover of reed canarygrass continued to decrease in Plots 1, 3 and 4, dropping from 62.1% in 2012 to 53.6% in 2014. Although the decrease from 2012 to 2014 was only marginally significant (p < 0.1), it represents a continuation of the 2006-2012 downward trend, and this benchmark was therefore met. Plot 2 was omitted from this analysis because it was not part of the planted area. Increasing native cover in the plots is illustrated in Figure 1, Section 4.

Figure 1. Changes in percent cover of herbaceous species in permanent vegetation monitoring plots 1-4 from 2006 to 2014. Species with >2% percent cover are shown.

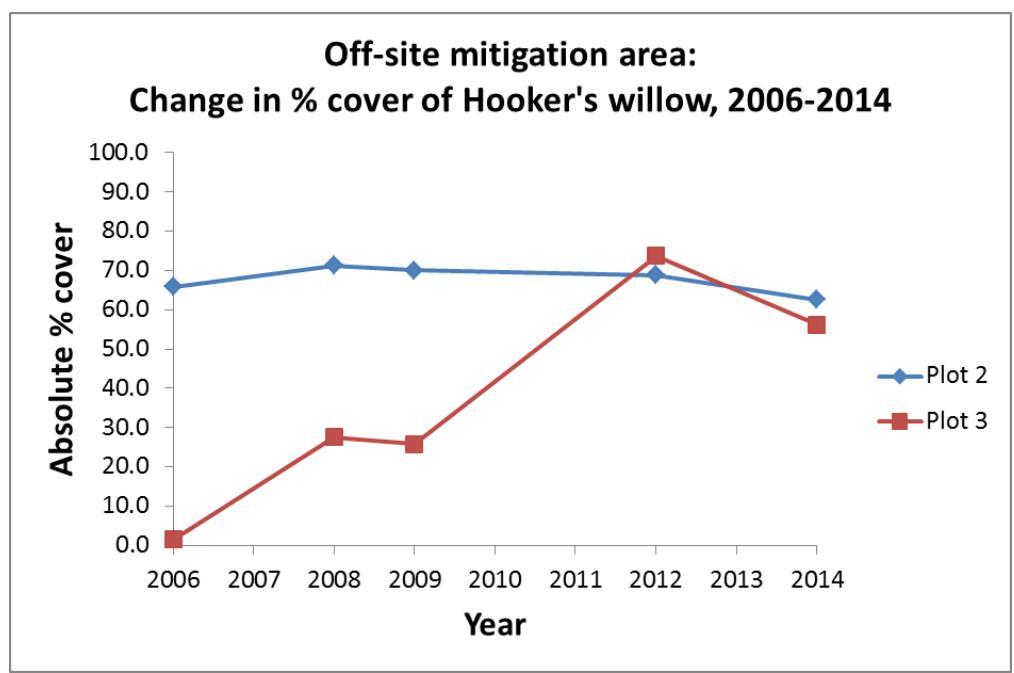
Figure 2. Changes in percent cover of Hooker's willow (*Salix hookeriana*) in permanent vegetation monitoring plots 2 and 3 from 2006 through 2014.

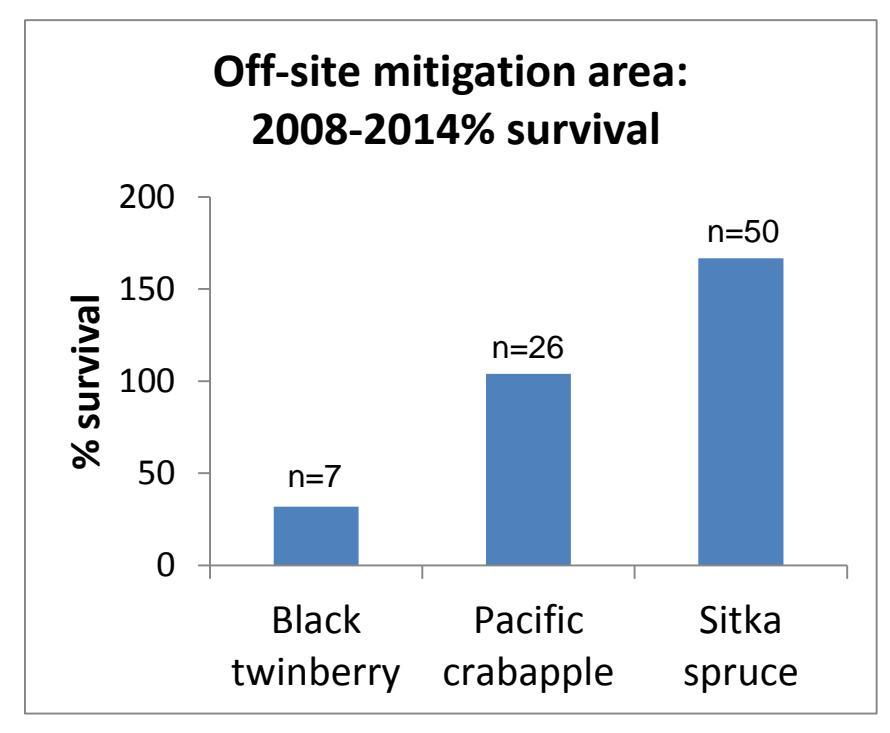
*Survival of woody plantings:* Survival of woody plantings across all species was 107.8% in 2014 (Figure 4, Section 4), with Sitka spruce survival over 100% due to additional plantings during 2008-2012. Pacific crabapple survival was also slightly over 100%, due to two additional plants counted in 2014 that were either missed during earlier counts, or recruited naturally. Survival of these two species is expected to be high in future years, since most individuals had grown tall enough by 2014 to escape browse pressure (see "**Protection from herbivory**" below). Black twinberry survival was lowest at 31.8%, but these plants can be difficult to locate due to their growth habit (they tend to fall over when stem diameter increases) and their location (near the edges of willow stands), so actual survival may be higher.

Figure 4: Survival of woody plantings, 2008-2014. Woody species were planted in March 2008. Number of surviving plantings is shown. Average survival overall was 107.8%; survival is >100% for spruce due to additional plantings in 2009-2010.

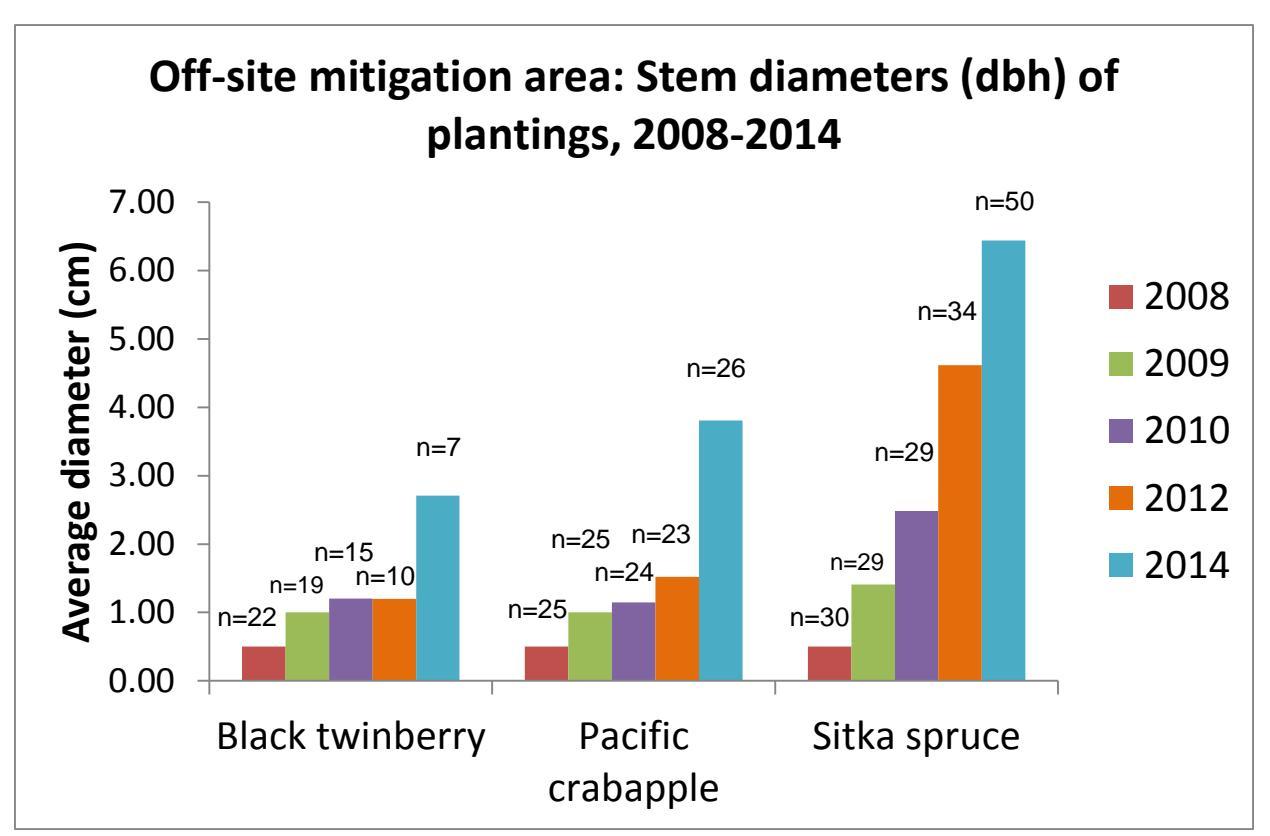
*Growth of woody plantings:* Stem diameter of Sitka spruce plantings has increased steadily since 2008, and this trend continues through 2014 (p < 0.0001) (Figure 5, Section 4). This rapid growth in diameter reflects the robust condition of most spruce on the site (Appendix 3, Table 3). Average stem diameter for Pacific crabapple and black twinberry stem increased between 2008 and 2014; the increase was significant for crabapple (p < 0.0001) but not for twinberry (p = 0.16) (Figure 5, Section 4).

Figure 5: Growth of stem diameter for woody plantings, 2008-2014. Stems >1 cm in diameter were measured and summed per plant, then averaged by species.

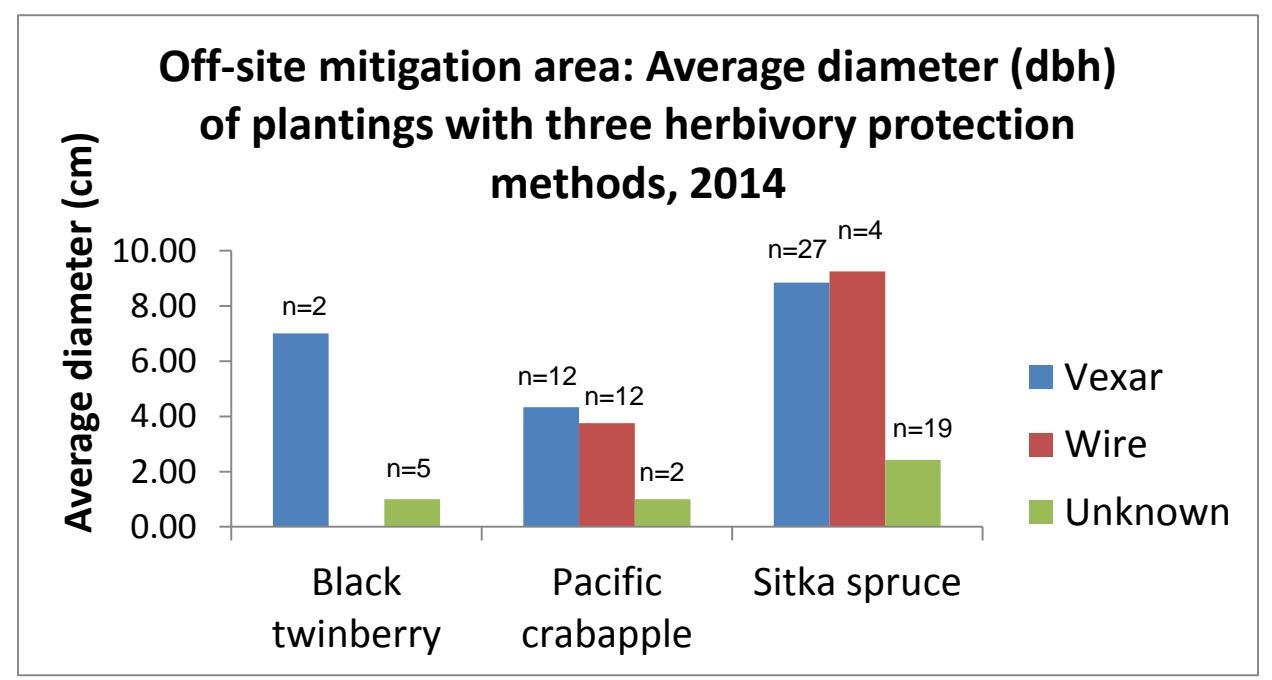
In 2014, herbivory protection method no longer had a strong effect on size or survival of plantings. The effects of herbivory protection method were seen mainly in the first few years of growth, when browse caused high mortality of shrubs. Regardless of protection method, most Sitka spruce were robust and grew fast from 2012 to 2014 (Figures 5 and 6, Section 4; Table 3, Appendix 3). Also regardless of protection method, most of the Pacific crabapple plantings were tall enough by 2014 to escape browse pressure (Table 3, Appendix 3), and were producing many new branches of substantial diameter (Figure 5, Section 4). Black twinberry plantings had high mortality from project inception to 2014; only 7 of the original 22 twinberry plantings (31.8%) survived in 2014. However, the surviving black twinberry shrubs were grew faster from 2012-2014 than in past years (Figure 5, Section 4). Based on our field observations at many wetland sites, the stems of black twinberry tend to fall over and grow horizontally near the ground after reaching 2-3 cm diameter. Because of this somewhat sprawling growth habit, few black twinberry shrubs have exceeded 10 ft height in 2014, and this is not expected for future years.

Figure 6: Average stem diameters (dbh) by species for woody plantings with three different herbivory protection methods, 2014. See Figure 5 for stem measurement methods.

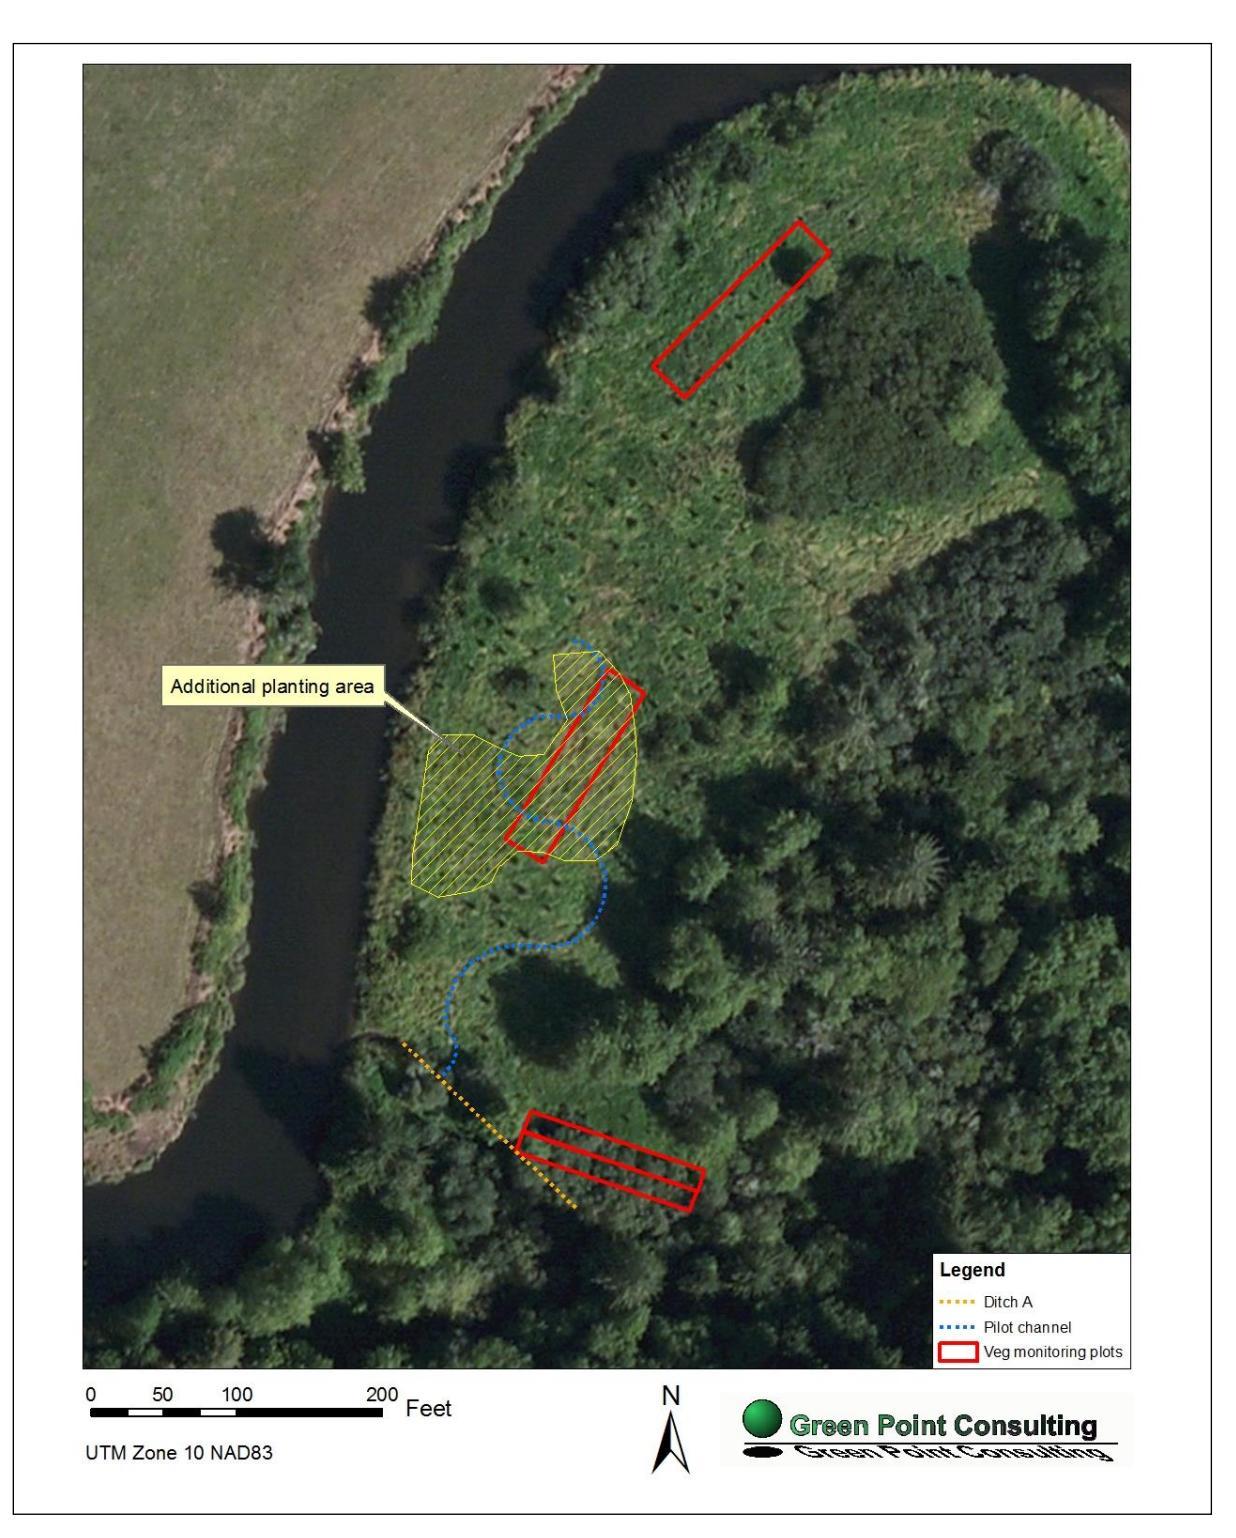
Map 7. Recommended area for additional Sitka spruce plantings. Spruce plantings are visible as dark dots in pasture; there are very few spruce in the recommended planting area. Vegetation monitoring plots are also shown. Background is 2011 satellite imagery.

The following recommendations were made in 2012 and are still applicable in 2014. Although the project meets nearly all performance benchmarks, some additional plantings could speed the site's restoration trajectory. Additional Sitka spruce plantings are recommended for the area marked in Map 7 (Appendix 1). Large stock is recommended, for rapid early growth above the reed canarygrass. Fifty to 100 Hooker willow cuttings at least 5ft tall are recommended along the banks of the pilot channel. Few of the past cuttings have emerged above the existing reed canarygrass canopy. If willow could be successfully established along this channel, it would help suppress reed canarygrass in the center of the site. To maximize root growth and potential for survival of top growth, willow cuttings should be planted in fall after the first rains have begun.

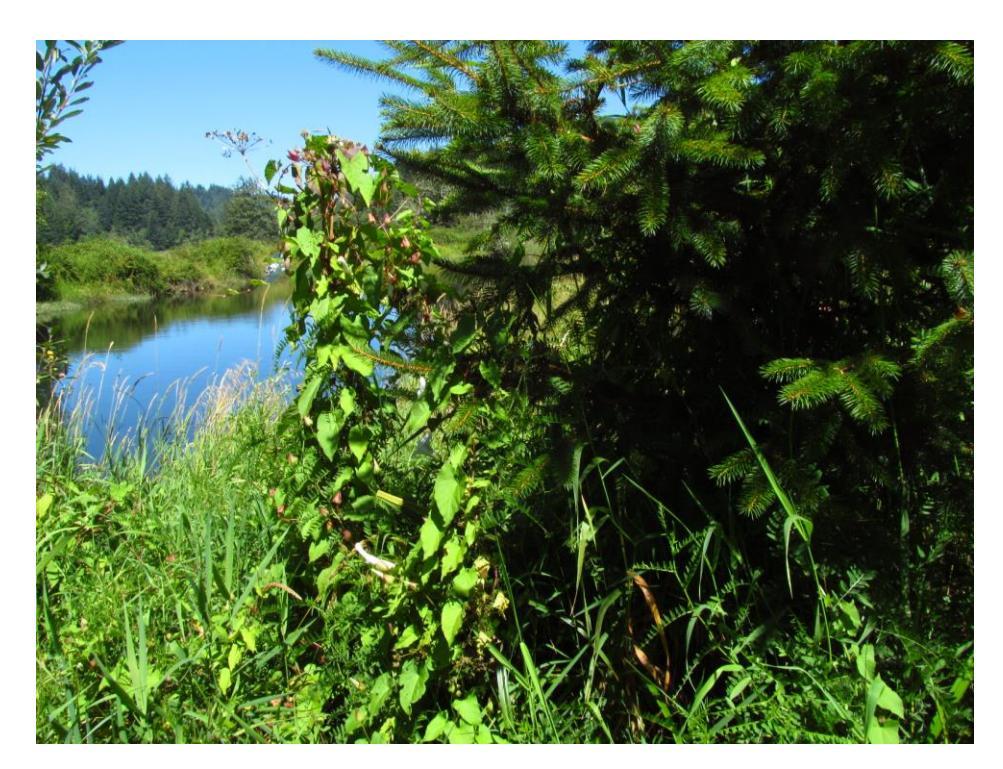
Photo 1. Photodocumentation Point 1A (left side of panorama). Breach area (from former dike). Planted Sitka spruce blocks most of the view at the original photo point.

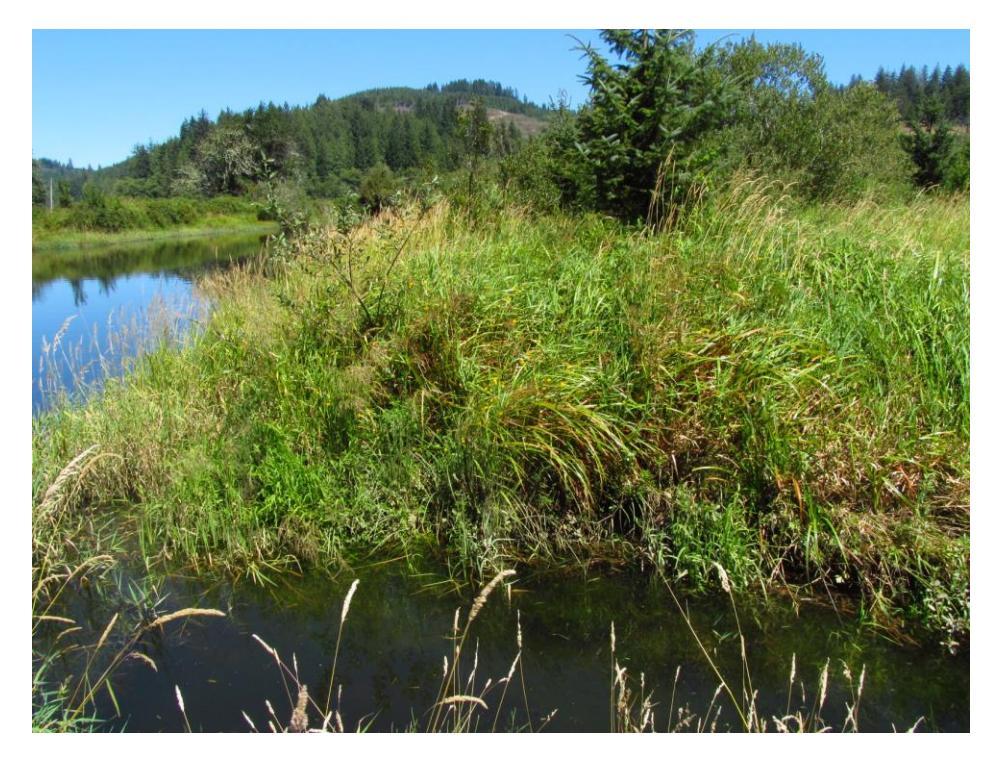
Photo 2. Photodocumentation Point 1A-1 (left side of panorama), taken from just north of the planted Sitka spruce to show breach area.

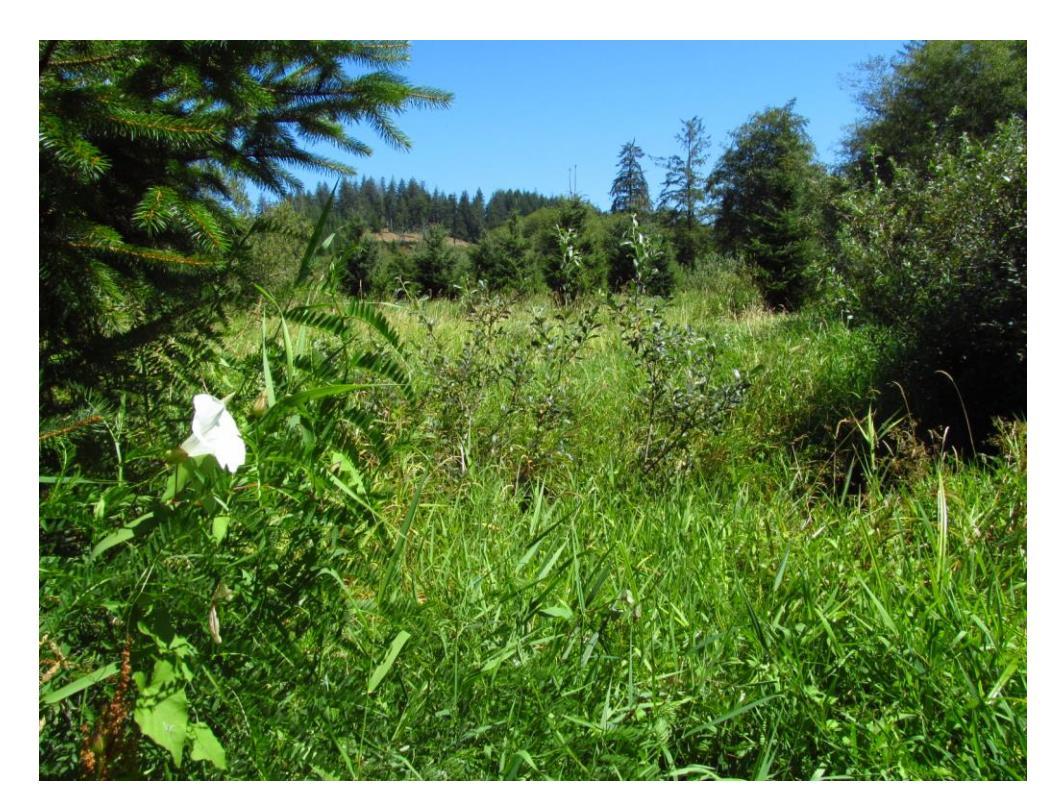
Photo 3. Photodocumentation Pt 1B (center of panorama). View NNE from just S of breach. Photo by L. Brophy.

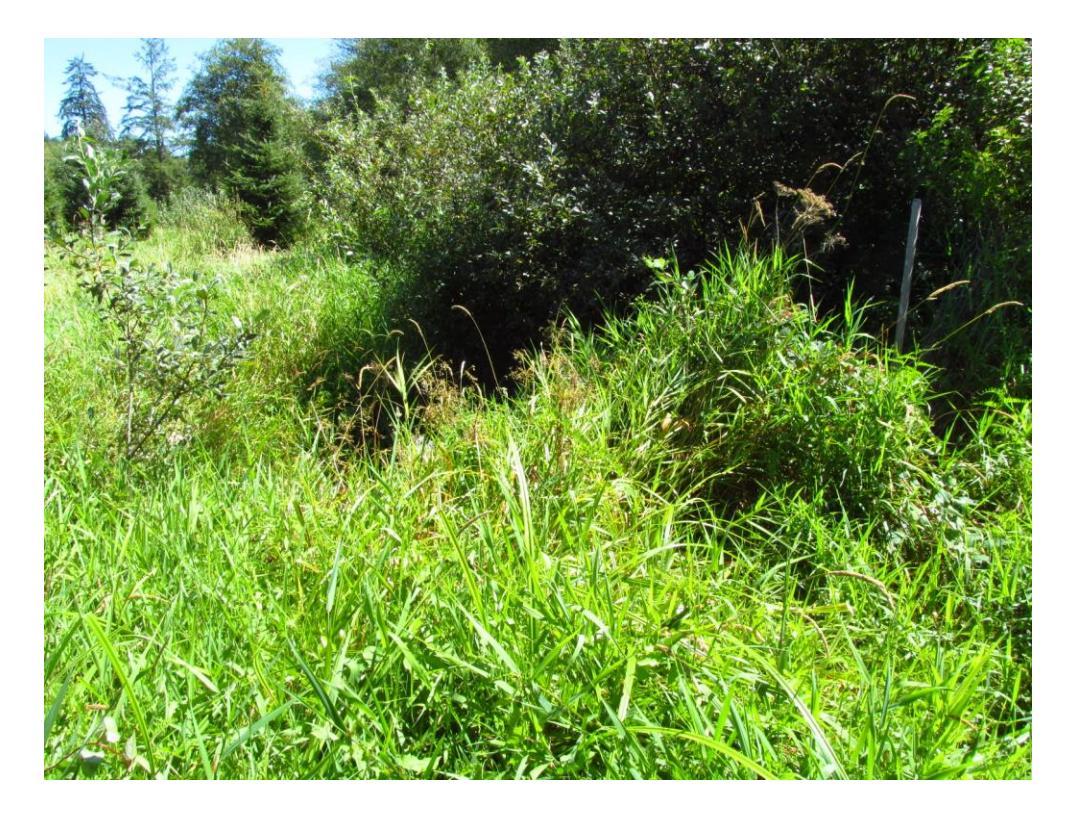
Photo 4. Photodocumentation Point 1C (right side of panorama). View ENE from S bank of breach; confluence of restored channel and ditch A is under the willows. Photo by L. Brophy.

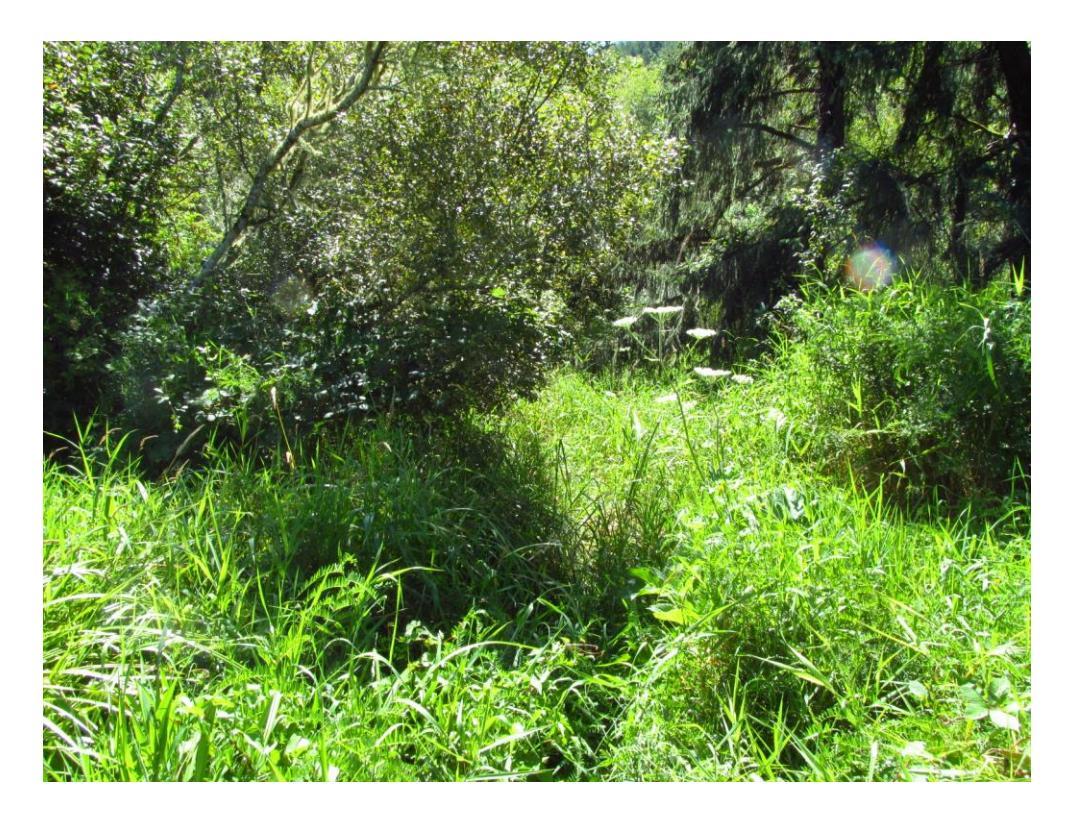
Photo 5. Photodocumentation Point 2. View S from breach area. Former equipment path is in center of photo. Photo by L. Brophy.

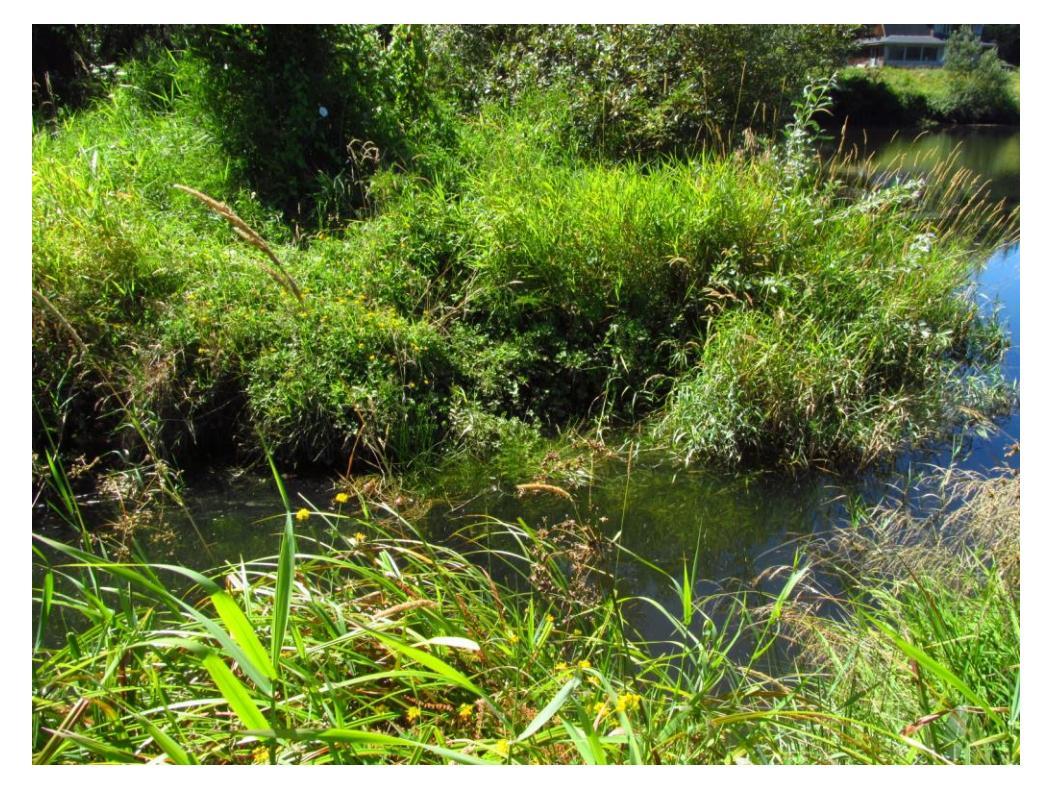
Photo 6. Photodocumentation Point 3. Mitigation site: View SW along former dike to mouth of breach. Photo by L. Brophy.

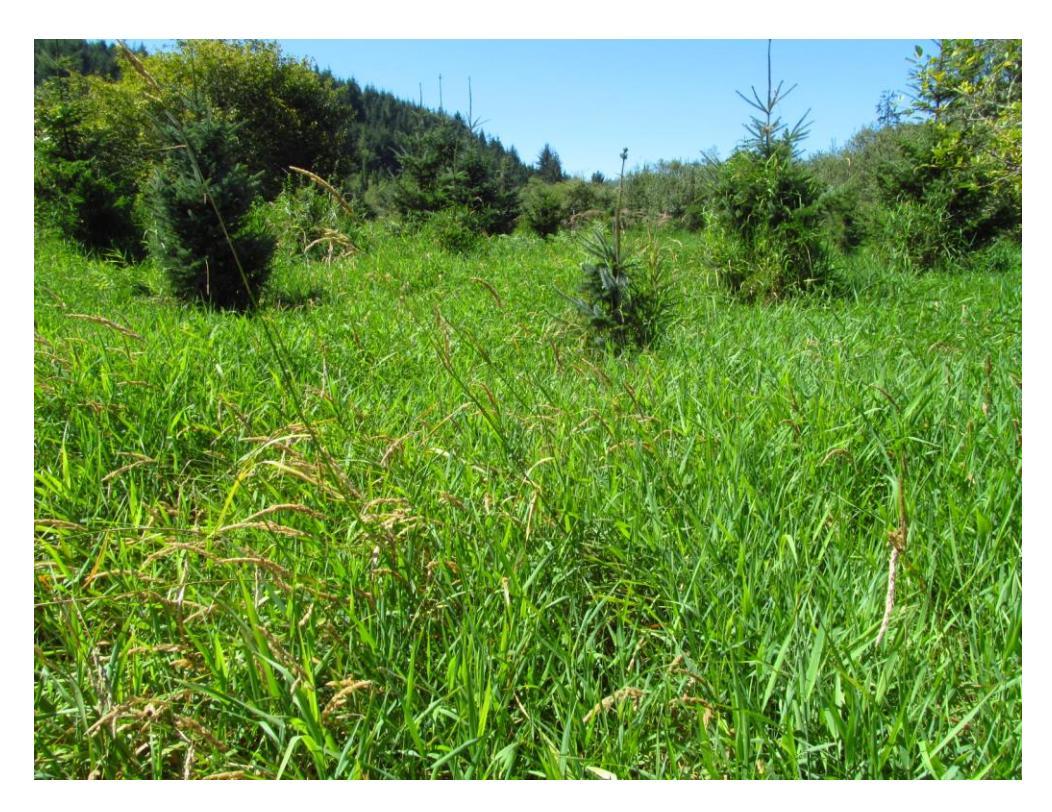
Photo 7. Photodocumentation Point 4. View SSW along length of pasture, from center of pasture. Photo by L. Brophy.

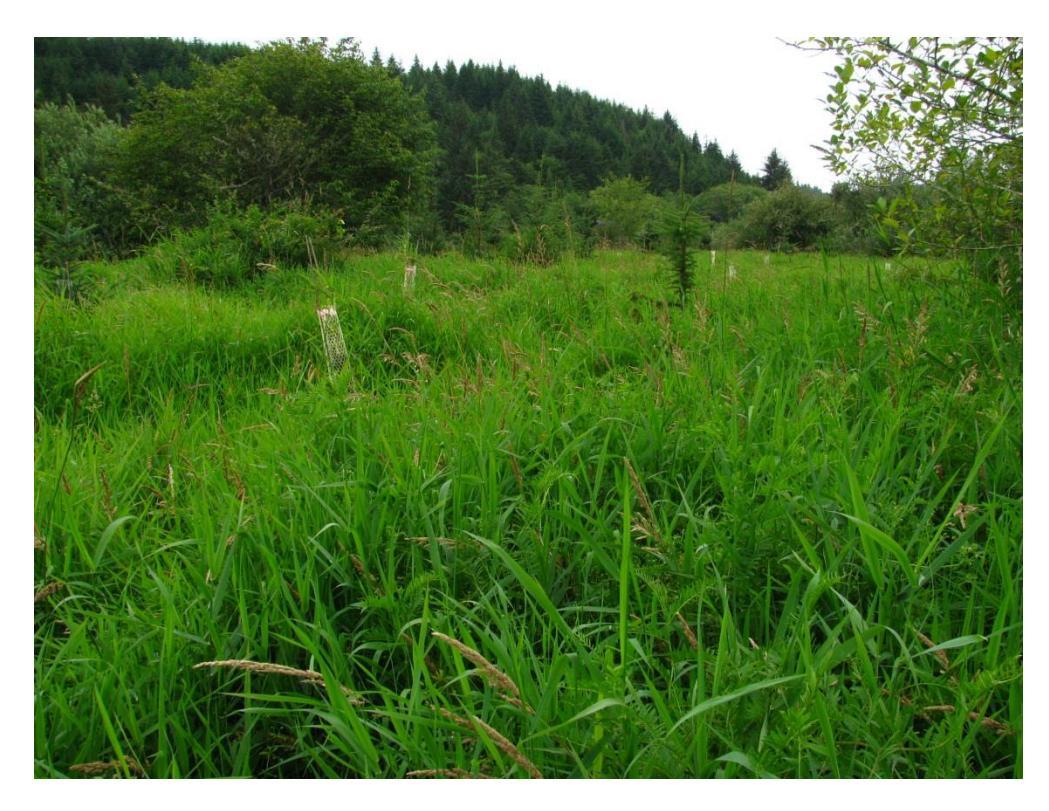
Photo 7. Photodocumentation Point 5. View SSW along length of pasture, from north end of pasture. Photo by L. Brophy.
