# Ni-les'tun Tidal Wetland Restoration Effectiveness Monitoring: Year 4 Post-restoration

Technical Report · December 2016

# Ni-les'tun tidal wetland restoration effectiveness monitoring: Year 4 post-restoration (2015)

Brown, L.A., M.J. Ewald, and L.S. Brophy. 2016. Ni-les'tun tidal wetland restoration effectiveness monitoring: Year 4 post-restoration (2015). Corvallis, Oregon: Estuary Technical Group, Institute for Applied Ecology.

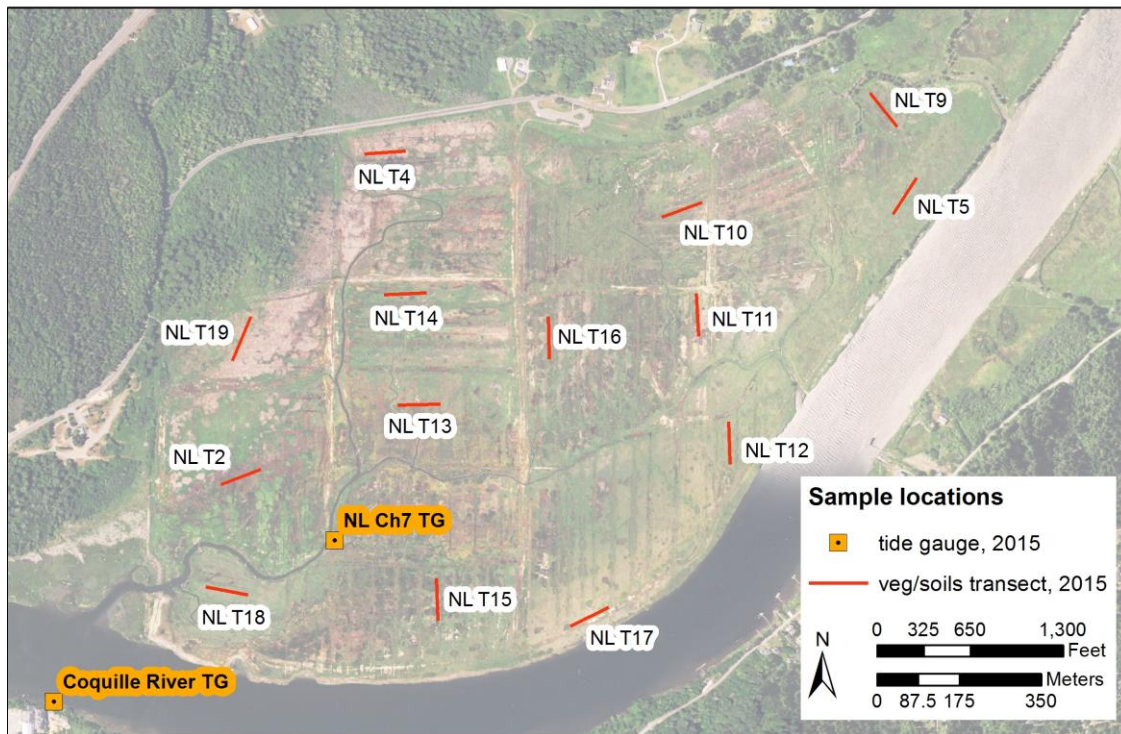
**Figure 1.** Ni-les'tun restoration site: 2015 sample transects for vegetation monitoring, and tidal hydrology gauge stations. Background: NAIP 2014.

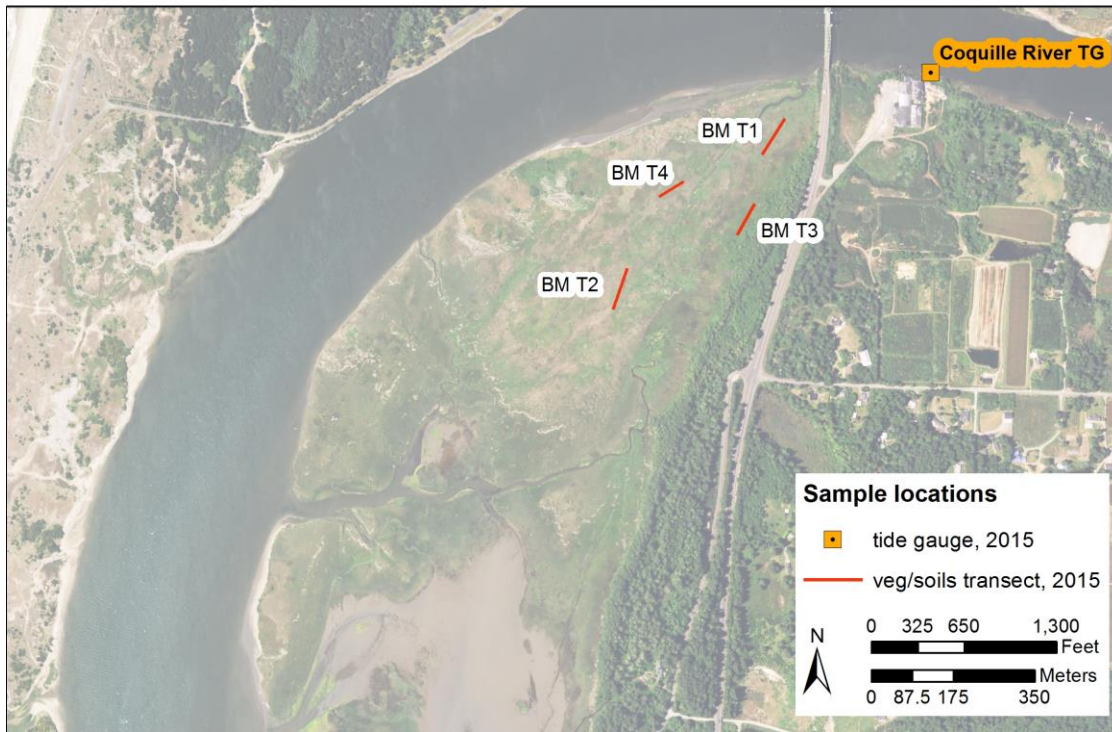
**Figure 2.** Bandon Marsh Unit reference site: 2015 sample transects for vegetation monitoring, and tidal hydrology gauge station. Background: NAIP 2014.

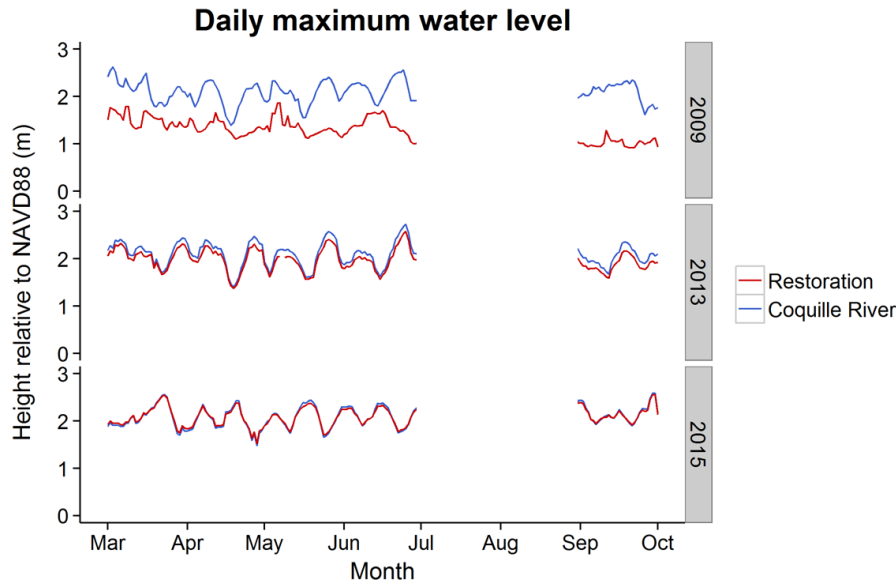
**Figure 3.** Pre-restoration (2009) and post-restoration (2013 and 2015) daily maximum tide heights for the Ni-les'tun restoration site, compared to the adjacent Coquille River. Restoration occurred on August 17, 2011. Data are shown for the analysis period of March 1 – July 8 and August 29 – October 1.

Tidal inundation (daily maximum water level) was fully restored at the Ni-les'tun restoration site (Figures 3 and 4). Daily maximum water levels inside the site in 2015 were not statistically different from those outside of the site (2.1 m at both locations). Prior to restoration (2009), daily maximum water levels were lower inside the restoration site compared to the river (1.3 m and 2.1 m, respectively). During year 2 after restoration (2013), daily maximum water levels inside the restoration site had increased significantly, to 2.0 m – much higher than during 2009, but still significantly lower than levels in the river (2.1 m). Year 4 (2015) monitoring showed matching daily maximum water levels in the river and inside the restoration site (Figures 3 and 4).

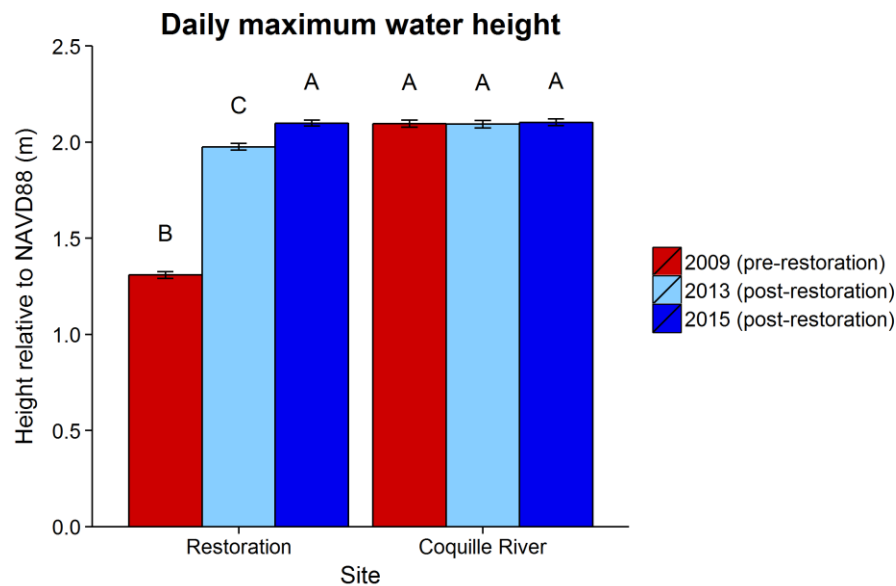
**Figure 4.** Average daily maximum water heights for the Ni-les'tun restoration site and Coquille River, pre- and post-restoration. Error bars show one standard error; columns with no letters in common are significantly different (ANOVA,  $p < 0.05$ ). Data are averaged from the full analysis period (March 1 – July 8 and August 29 – October 1) in each year.

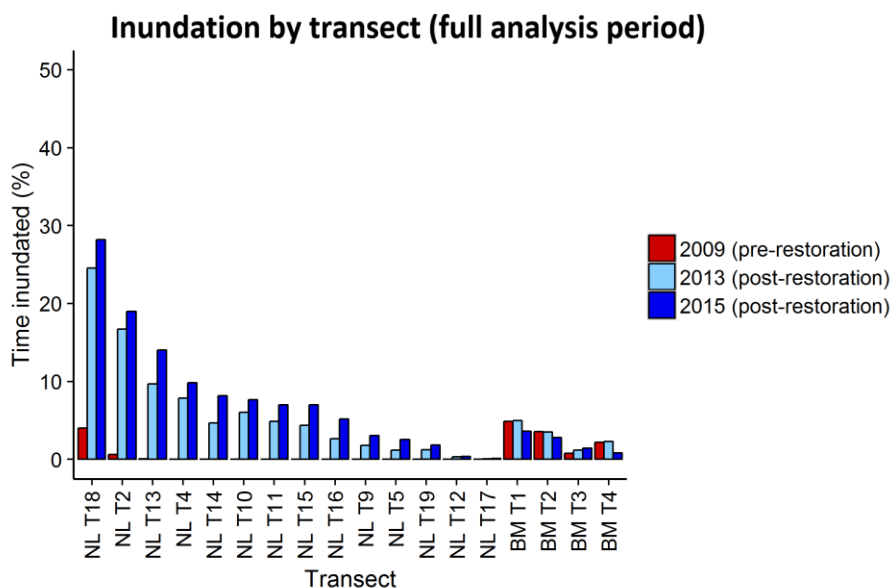
**Figure 5.** Percent inundation pre- (2009) and post-restoration (2013 and 2015) for sample transects at Ni-les'tun (NL) and the Bandon Marsh Unit reference site (BM). Transects are ordered by ascending elevation (measured in 2015) within each site, with NL T18 and BM T1 having the lowest elevation, NL T17 and BM T4 the highest. Data are averaged from the full analysis period (March 1 – July 8 and August 29 – October 1) for each year.

Percent inundation was higher during 2015 compared to year 2 after restoration (2013) at the restoration site, but not at the reference site (Figure 5). This reflects full restoration of tidal forces at the site, and may also reflect the characteristics of the specific observation periods (see next paragraph).

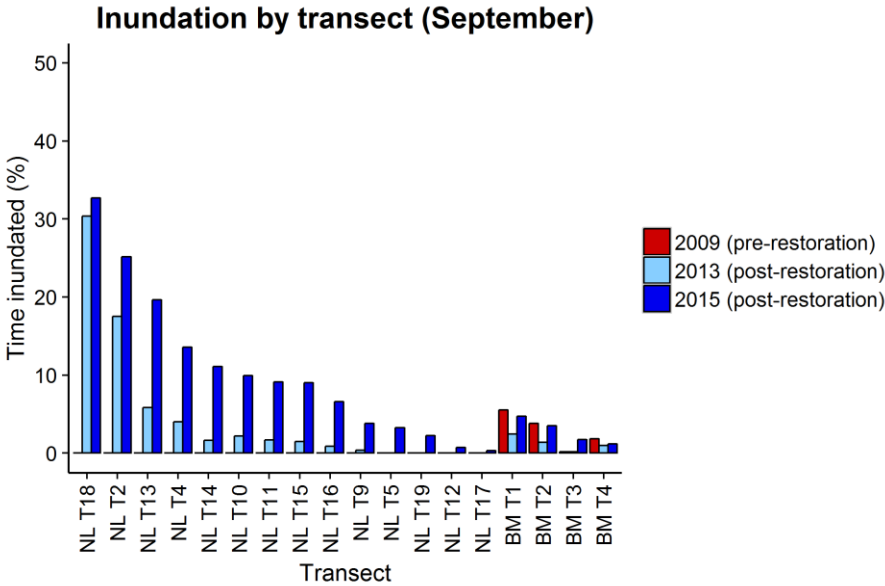
**Figure 6.** Percent inundation in September during pre- (2009) and post-restoration (2013 and 2015) periods for sample transects at Ni-les’tun (NL) and the Bandon Marsh Unit reference site (BM). Transects are ordered by ascending elevation (measured in 2015) within each site, with NL T18 and BM T1 having the lowest elevation, NL T17 and BM T4 the highest.

Surprisingly, percent inundation in September 2015 was similar to March 2015 (Figures 5-7), and considerably greater than September 2013 (Figures 6 and 7). Since late summer precipitation was similar in 2013 and 2015, we expect the higher inundation in September 2015 was probably due to the observation period encompassing two spring tide cycle peaks. (The March observation period encompassed only a single spring tide peak). Typically, Oregon tidal wetlands are inundated more often during winter and spring months compared to dry summer months (Seliskar and Gallagher 1983, Brophy *et al.* 2011); longer observation periods in winter and summer, or modeling of long-term tidal hydrology, would likely have revealed this more typical pattern. Although beyond the scope of this project, modeling tidal hydrology at Ni-les'tun would generate deeper understanding of this important controlling factor and the resulting site development.

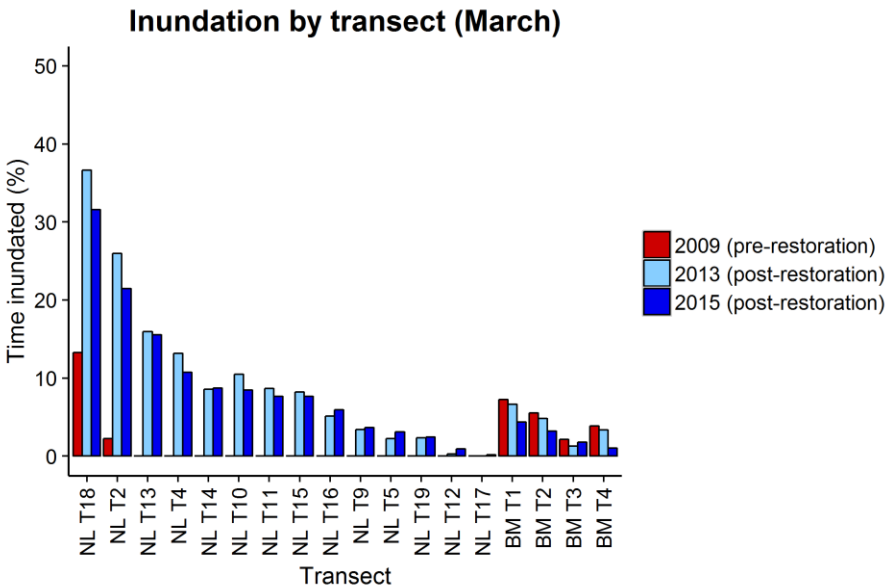
**Figure 7.** Percent inundation in March pre- (2009) and post-restoration (2013 and 2015) for sample transects at Ni-les’tun (NL) and the Bandon Marsh Unit reference site (BM). Transects are ordered by ascending elevation (measured in 2015) within each site, with NL T18 and BM T1 having the lowest elevation, NL T17 and BM T4 the highest.

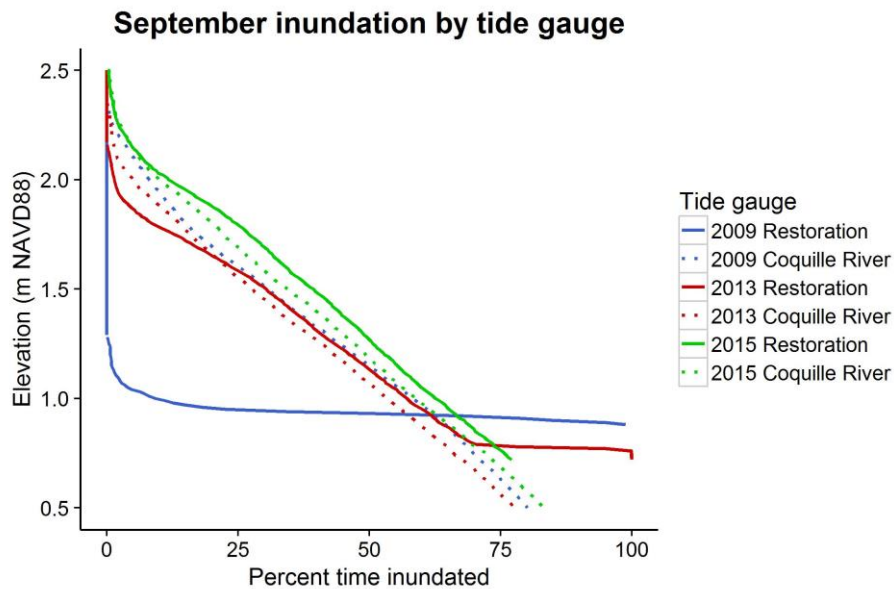
**Figure 8.** Percent inundation at a range of elevations during the summer period (September) at the restoration site and Coquille River tide gauges, pre (2009) and post-restoration (2013 and 2015). Average wetland surface elevation at Ni-les’tun is 2.08 m NAVD88 (see Table 4).

Using the tide gauge data, we graphed percent inundation (or “exceedance”) for a broad range of elevations at Ni-les’tun and in the adjacent Coquille River. In 2015, tidal inundation of the wetland surface at Ni-les’tun (mostly at elevations of 1.8 to 2.5 m) closely matched the adjacent river, whereas in 2013 (particularly in September), the wetland surface was less frequently inundated (Figures 8-10). The

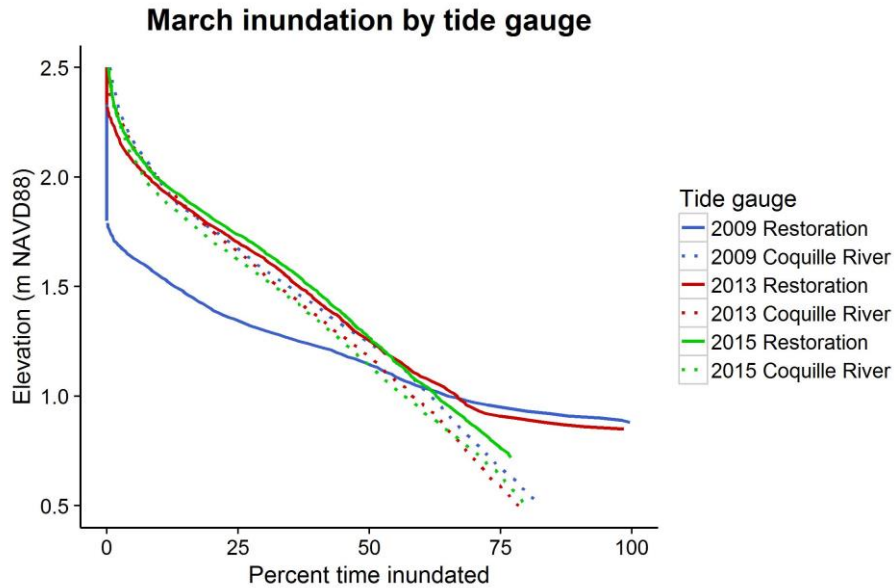
**Figure 9.** Percent inundation at a range of elevations during March at the restoration site and Coquille River tide gauges, pre (2009) and post-restoration (2013 and 2015). Average wetland surface elevation at Ni-les'tun is 2.08 m NAVD88 (see Table 4). Note: The March curve for the Coquille River is hidden directly under the restoration site curve (i.e., the restoration site and river matched exactly in March).

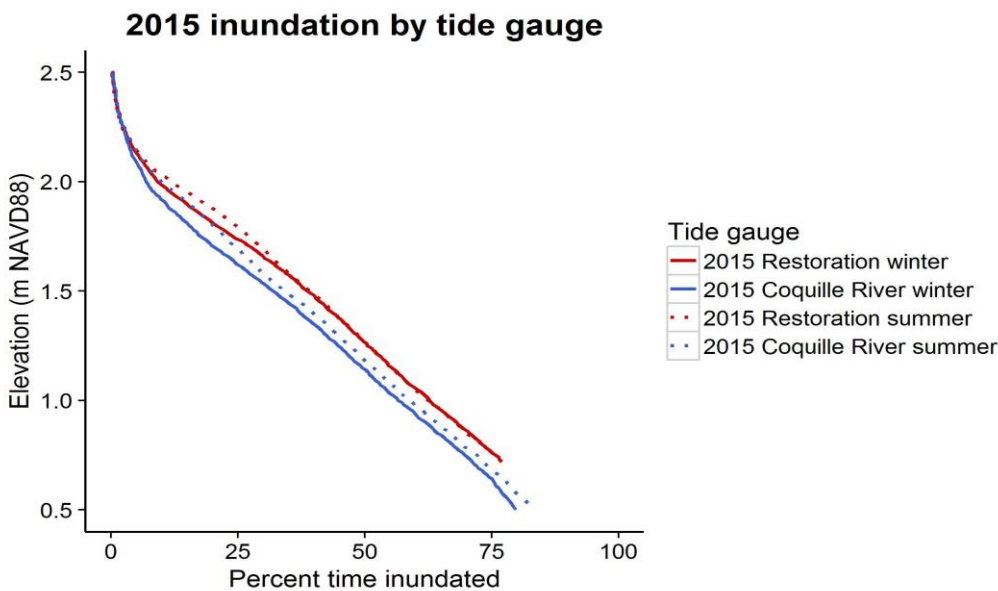
**Figure 10.** Percent inundation at a range of elevations during 2015 at the restoration site and Coquille River tide gauges, late winter (March) and summer (September). Average wetland surface elevation at Ni-les'tun is 2.08 m NAVD88 (see Table 4).

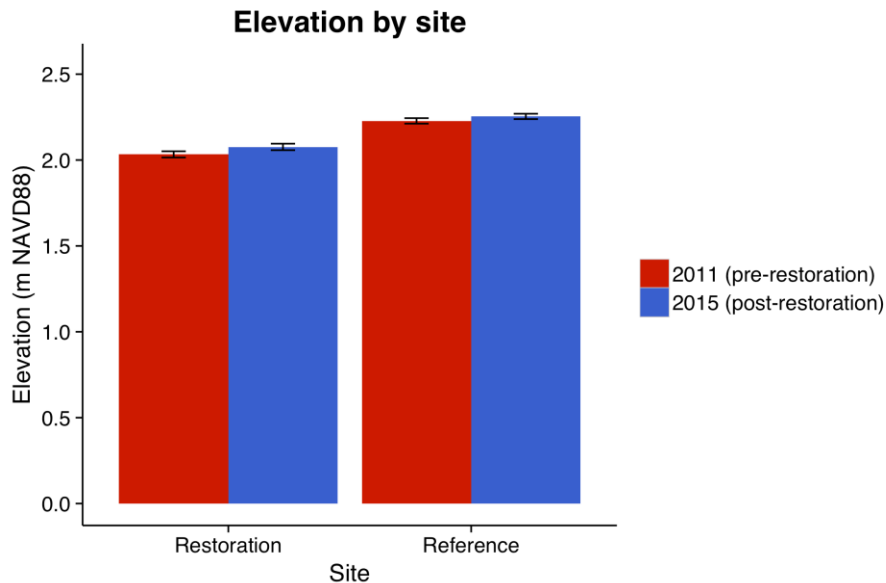
**Figure 11.** Wetland surface elevation at Ni-les'tun (restoration) and the Bandon Marsh Unit reference site (reference). Error bars show one standard error. Vertical datum: NAVD88 (GEOID12A).

Because the Ni-les'tun site is subsided (Brophy *et al.* 2014, Brophy and van de Wetering 2011), the average elevation across all transects at the Ni-les'tun restoration site was somewhat lower than at the Bandon Marsh Unit reference site. In 2015, the average transect elevations at Ni-les'tun restoration site and the Bandon Marsh Unit were 2.08 m and 2.25 m NAVD88 ([GEOID12A], respectively) (Table 4, Figure 11). In 2011, the average wetland surface elevation (averaged across all transects) was 2.03 m NAVD88 (GEOID12A) at the Ni-les'tun restoration site and 2.23 m NAVD88 (GEOID12A) at the Bandon Marsh reference site.

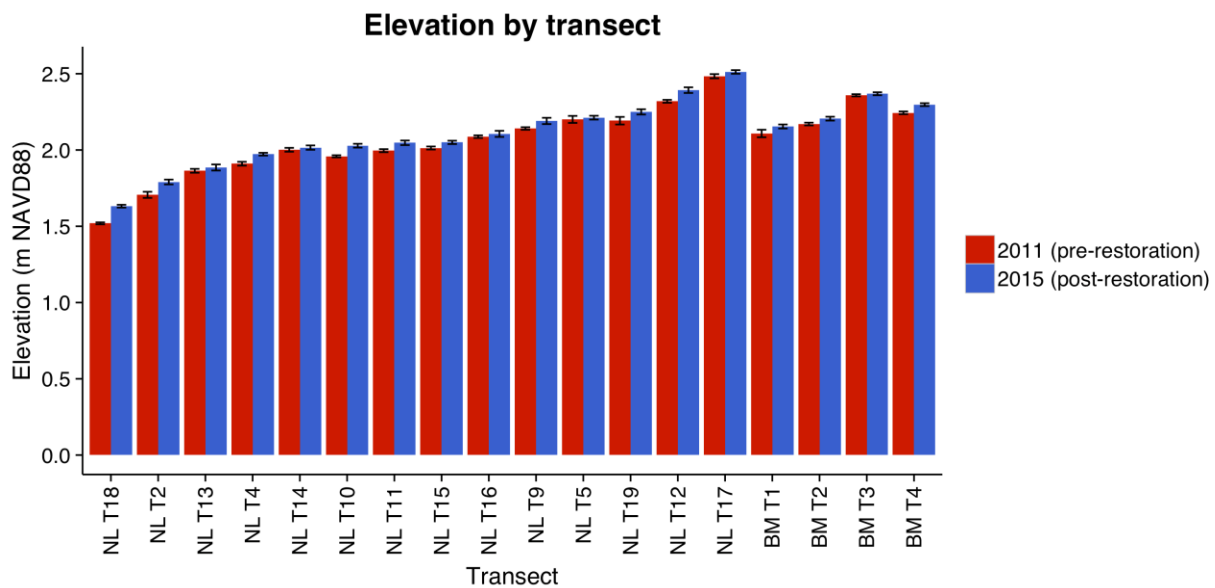
**Figure 12.** Wetland surface elevations by transect at Ni-les'tun (restoration) and the Bandon Marsh Unit reference site (reference). Transects are ordered by ascending elevation (measured in 2015) within each site, with NL T18 and BM T1 having the lowest elevation, NL T17 and BM T4 the highest. Error bars show one standard error. Vertical datum: NAVD88 (GEOID12A).

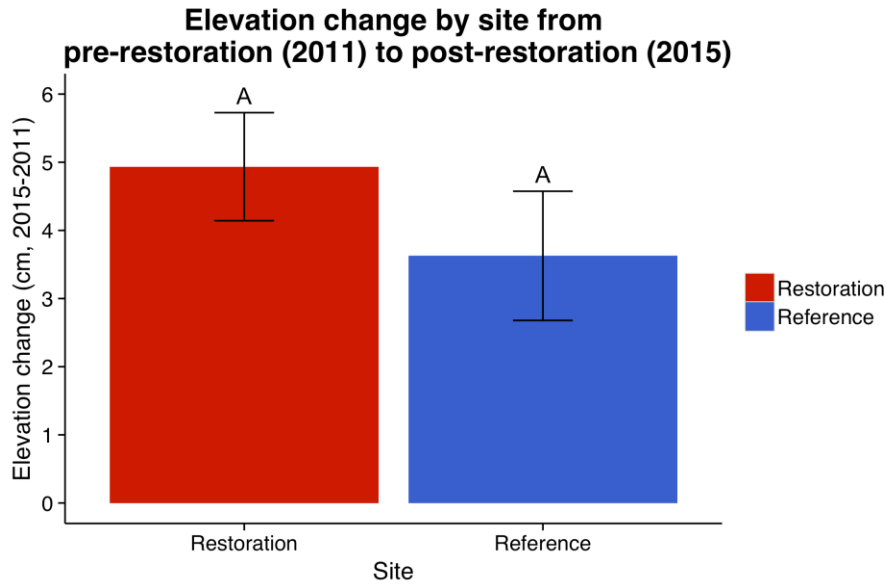
**Figure 13.** Wetland surface elevation change by site at Ni-les'tun (restoration) and the Bandon Marsh Unit reference site (reference). Error bars show one standard error; columns with no letters in common are significantly different (Wilcoxon test,  $p < 0.05$ ).

There was no significant difference in the change of elevation between the restoration site and reference site ( $p = 0.37$ , Figures 13-15).

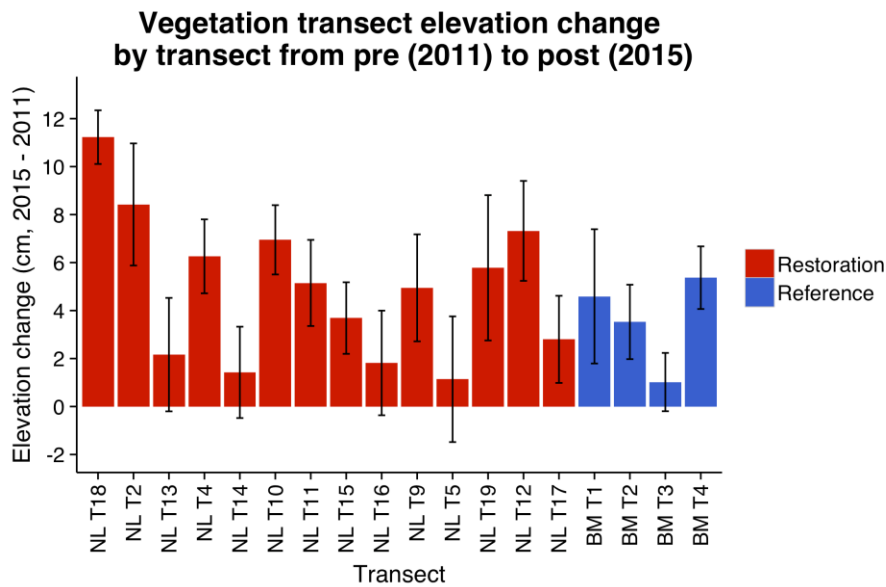
**Figure 14.** Wetland surface elevation change from pre-restoration baseline (2011) to year 4 (2015), by transect, at Ni-les'tun (restoration) and the Bandon Marsh Unit reference site (reference). Transects are ordered by ascending elevation (measured in 2015) from left to right within each site, with NL T18 and BM T1 having the lowest elevation, NL T17 and BM T4 the highest. Error bars show one standard error.

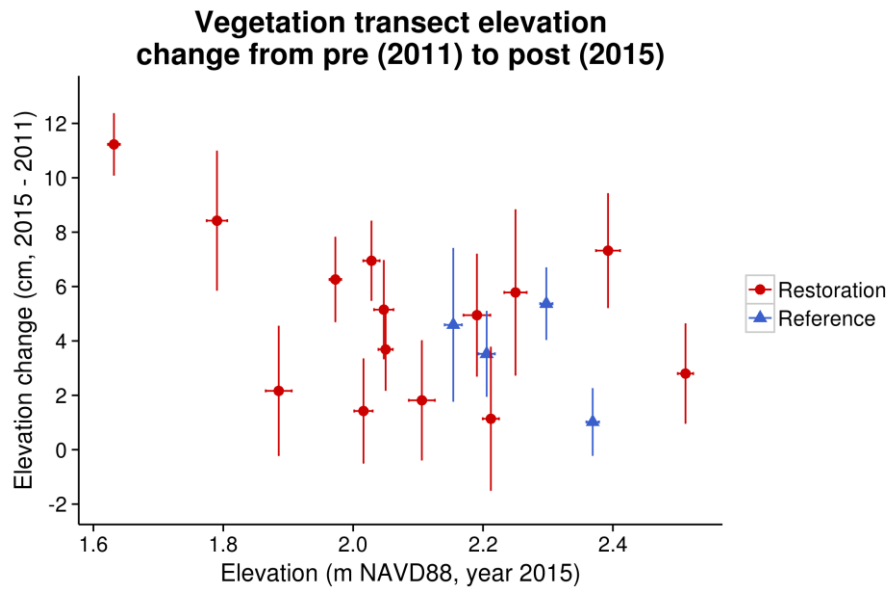
**Figure 15.** Wetland surface elevation change from pre-restoration baseline (2011) to year 4 (2015), as a function of elevation, at Ni-les'tun (restoration) and the Bandon Marsh Unit reference site (reference). Error bars show one standard error.

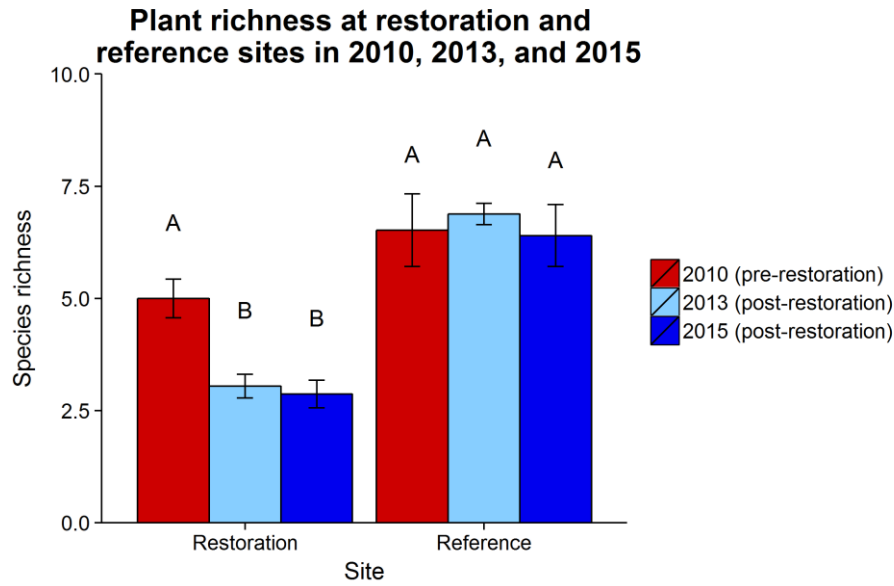
**Figure 16.** Average plant species richness for the Ni-les'tun restoration site and Bandon Marsh Unit reference site, pre- and post-restoration. Error bars show one standard error; columns with no letters in common are significantly different (ANOVA,  $p < 0.05$ ).

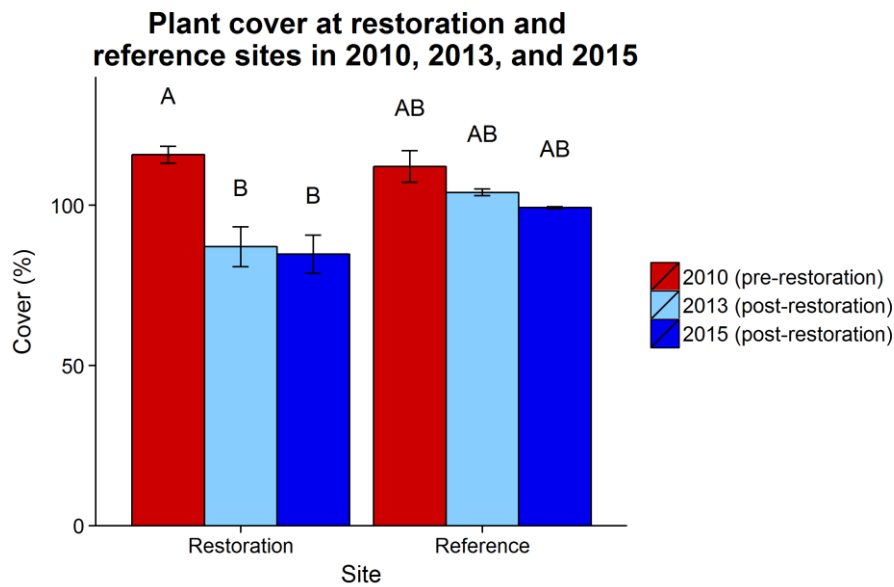
**Figure 17.** Average plant cover for the Ni-les'tun restoration site and Bandon Marsh Unit reference site, pre- and post-restoration. Error bars show one standard error; columns with no letters in common are significantly different (ANOVA,  $p < 0.05$ ).

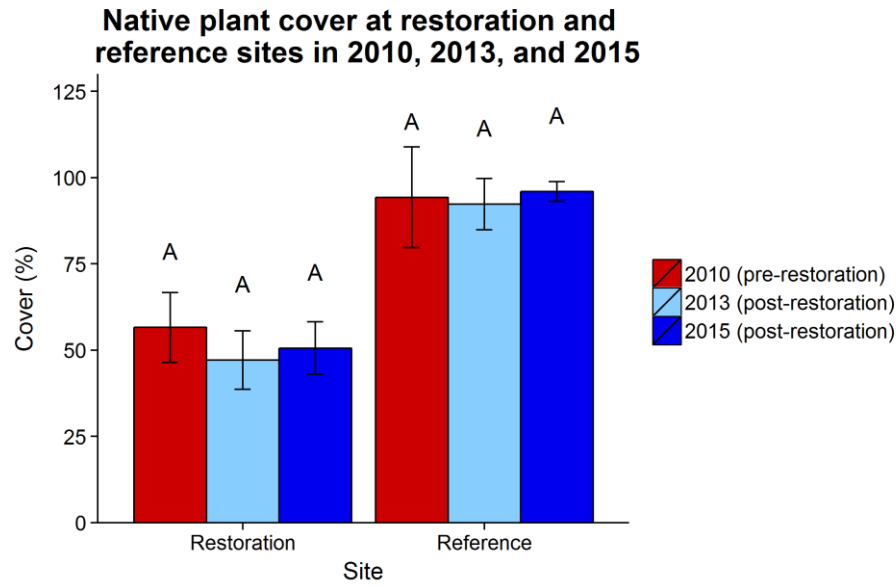
**Figure 18.** Average native plant cover for the Ni-les'tun restoration site and Bandon Marsh Unit reference site, pre- and post-restoration. Error bars show one standard error; columns with no letters in common are significantly different (ANOVA,  $p < 0.05$ ).

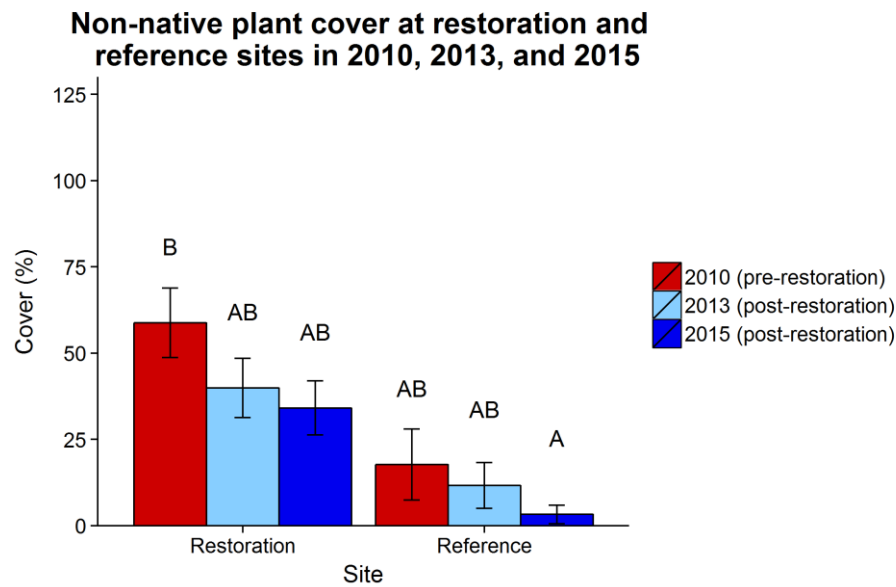
**Figure 19.** Average non-native plant cover for the Ni-les'tun restoration site and Bandon Marsh Unit reference site, pre- and post-restoration. Error bars show one standard error; columns with no letters in common are significantly different (ANOVA,  $p < 0.05$ ).

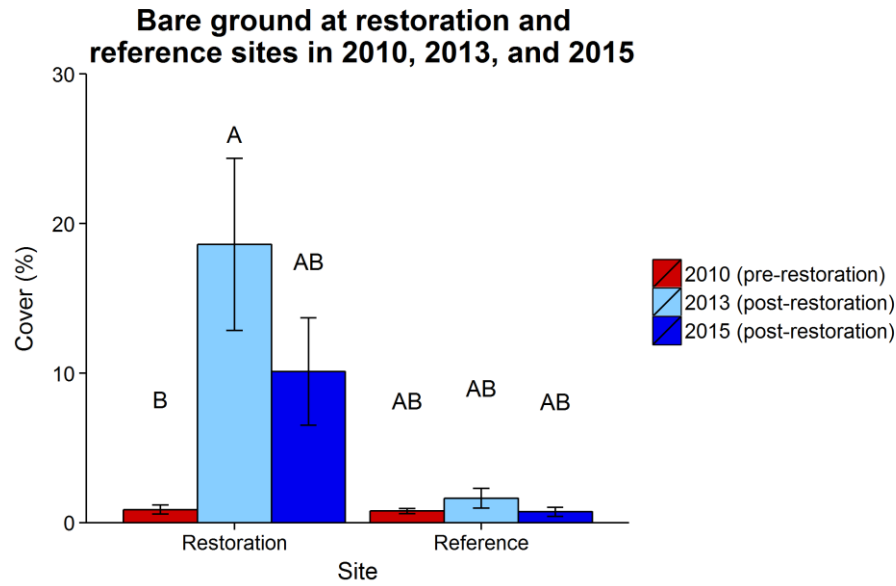
**Figure 20.** Average bare ground cover for the Ni-les'tun restoration site and Bandon Marsh Unit reference site, pre- and post-restoration. Error bars show one standard error; columns with no letters in common are significantly different (ANOVA,  $p < 0.05$ ).

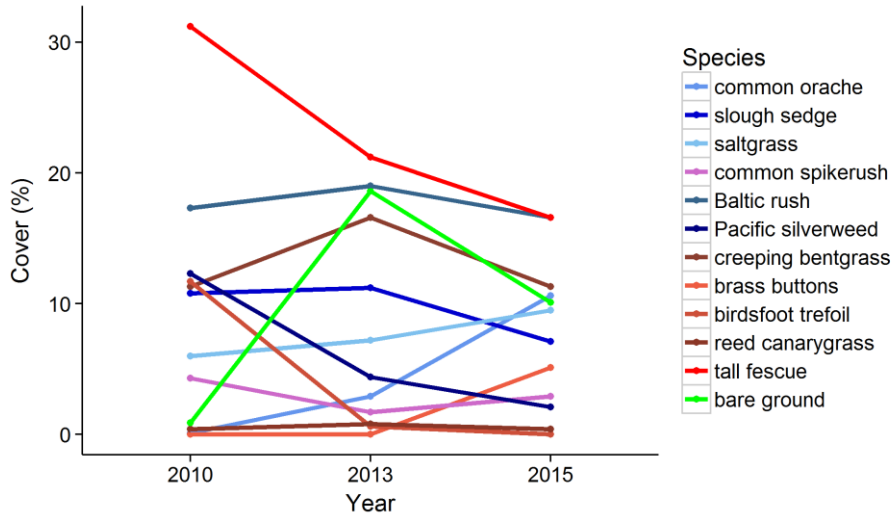
**Figure 21.** Species change in percent cover at the Ni-les'tun restoration site from 2010 to 2015. Native species are in blues and purples, while non-native species are in reds and oranges. Figure includes only species with more than 5% average cover in any single transect.

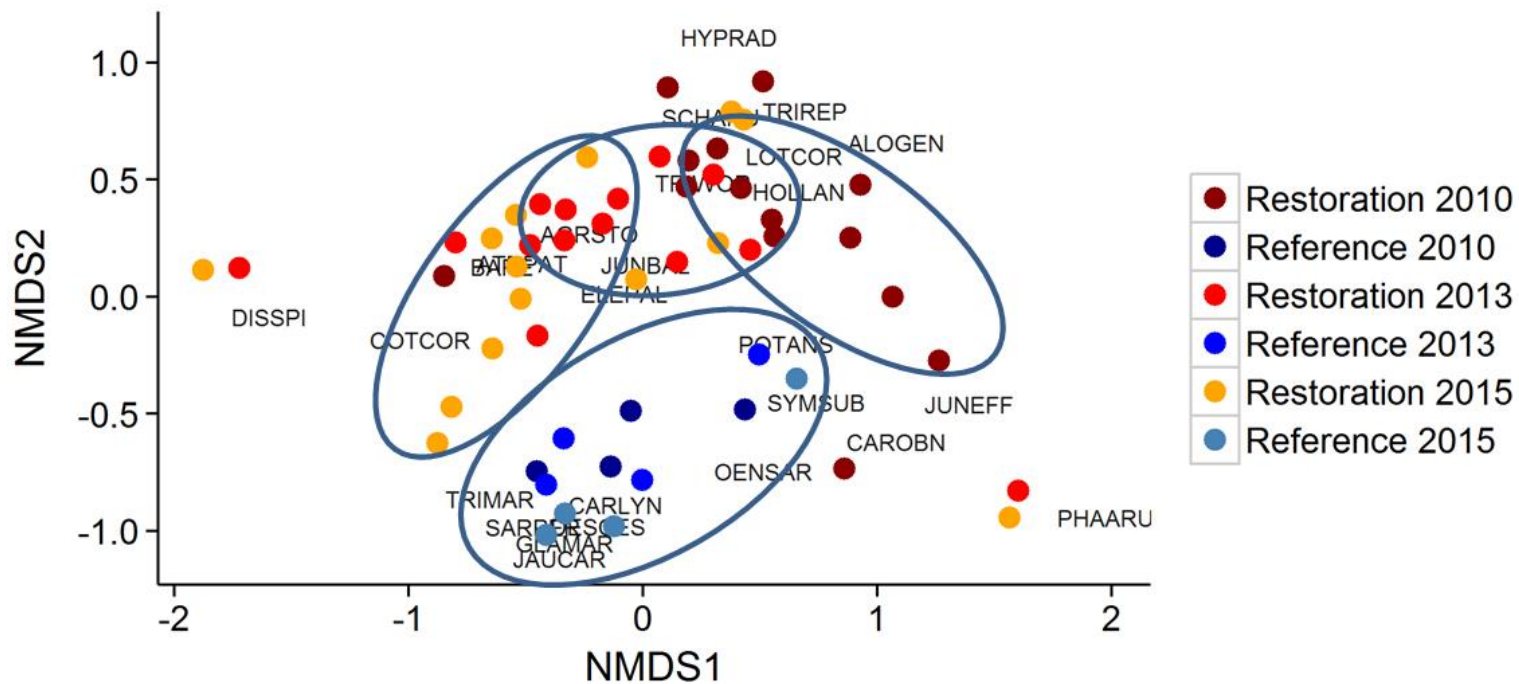
**Figure 22.** Non-metric multidimensional scaling (NMDS) plot for pre-restoration (2010) and post-restoration (2013 and 2015) plant communities at the Ni-les'tun restoration site and Bandon Marsh reference site. Red/orange dots represent transects from the restoration site; blue dots indicate transects from the reference site. Each point represents a single transect, with percent cover averaged for all quadrats per transect. Points closer together are more similar compositionally. The centroid positions of species used in the analysis are also indicated by six letter species codes on the plot. Restoration site transects from 2015, for instance, are near the COTCOR centroid, indicating they have greater cover of *Cotula coronopifolia* than most reference transects.

The NMDS analysis showed that plant communities in Ni-les'tun transects were gradually moving towards low salt marsh component of the reference transects (stress = 0.18, Figure 22). The ellipses in Figure 22 group each year's samples at the restoration site, showing the transition from associations dominated by agricultural grasses (HOLLAN and SCHARU) to associations dominated by low marsh plants communities (JAUMAR and DISSPI) (Figure 22). This result was expected, since the reference site transects were chosen to represent the original high marsh that was found at Ni-les'tun historically, so their elevation is higher than the subsided wetland surface at Ni-les'tun. The increase in salt-tolerant species at Ni-les'tun (such as saltgrass and common orache) is leading to closer similarity to low salt marsh found at the reference site (but not currently sampled), rather than the high salt marsh represented by the Bandon Marsh Unit transects. Over time, accretion at Ni-les'tun may lead to recovery of high salt marsh, but the process is expected to take many decades.

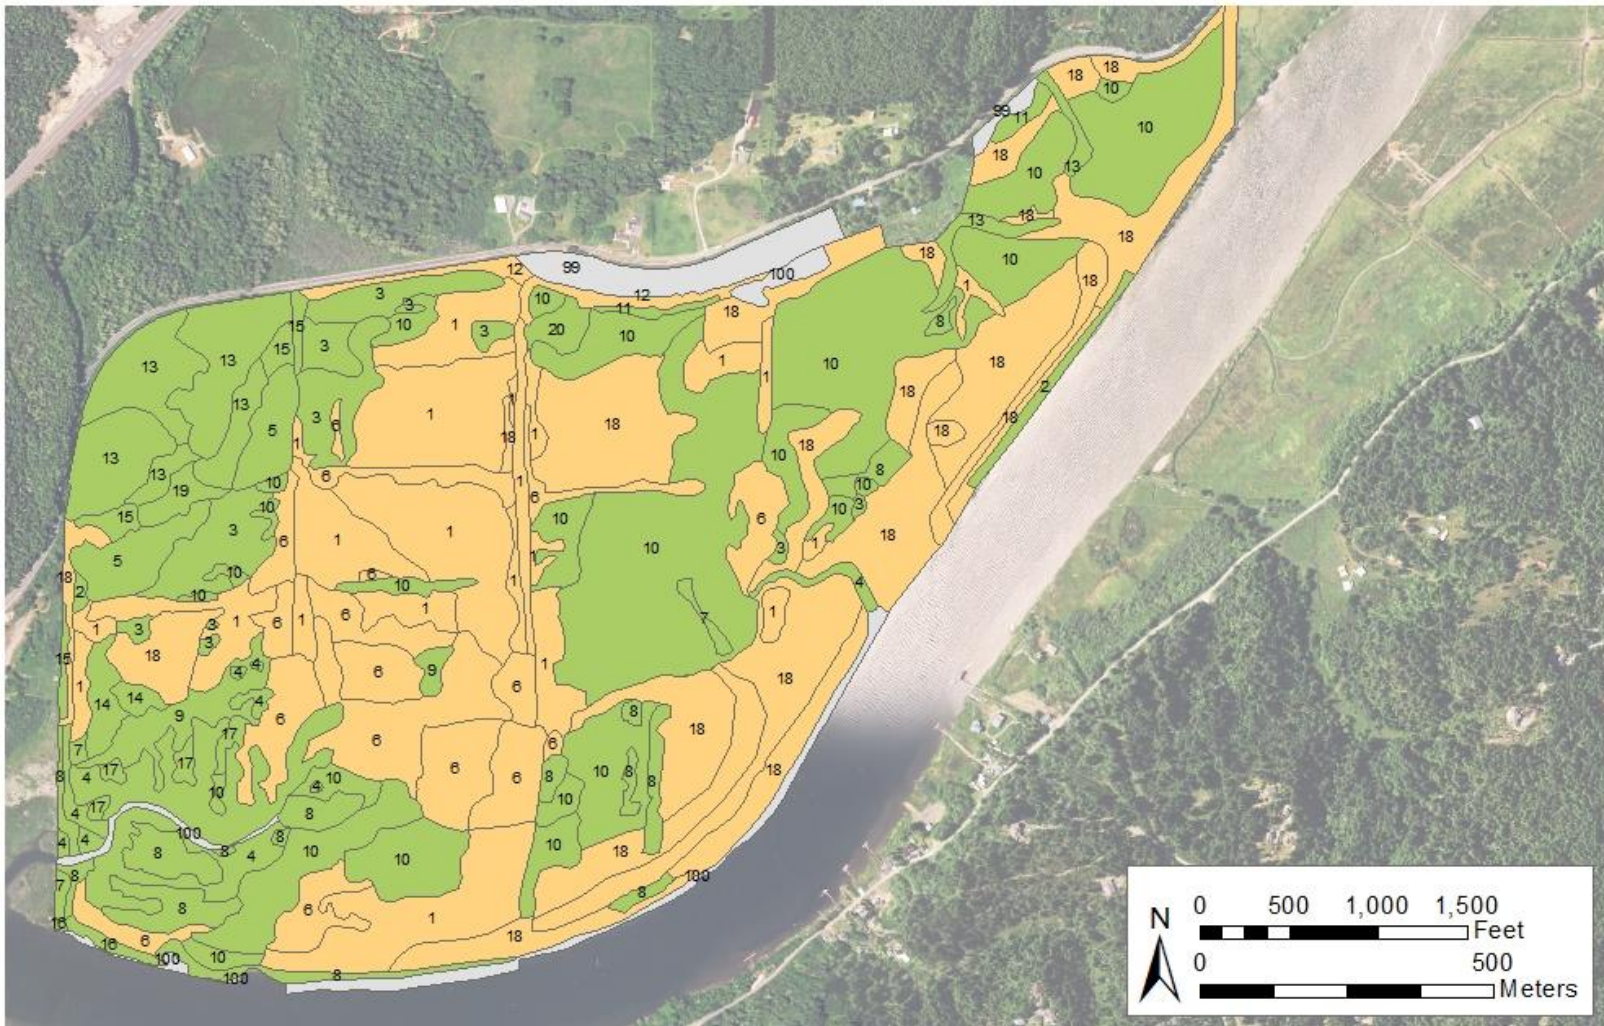
Figure 23. Plant communities at Ni-les'tun in 2015, showing areas dominated by native versus non-native species. Labels show alliance numbers (see Appendix 2, Table A2-1).

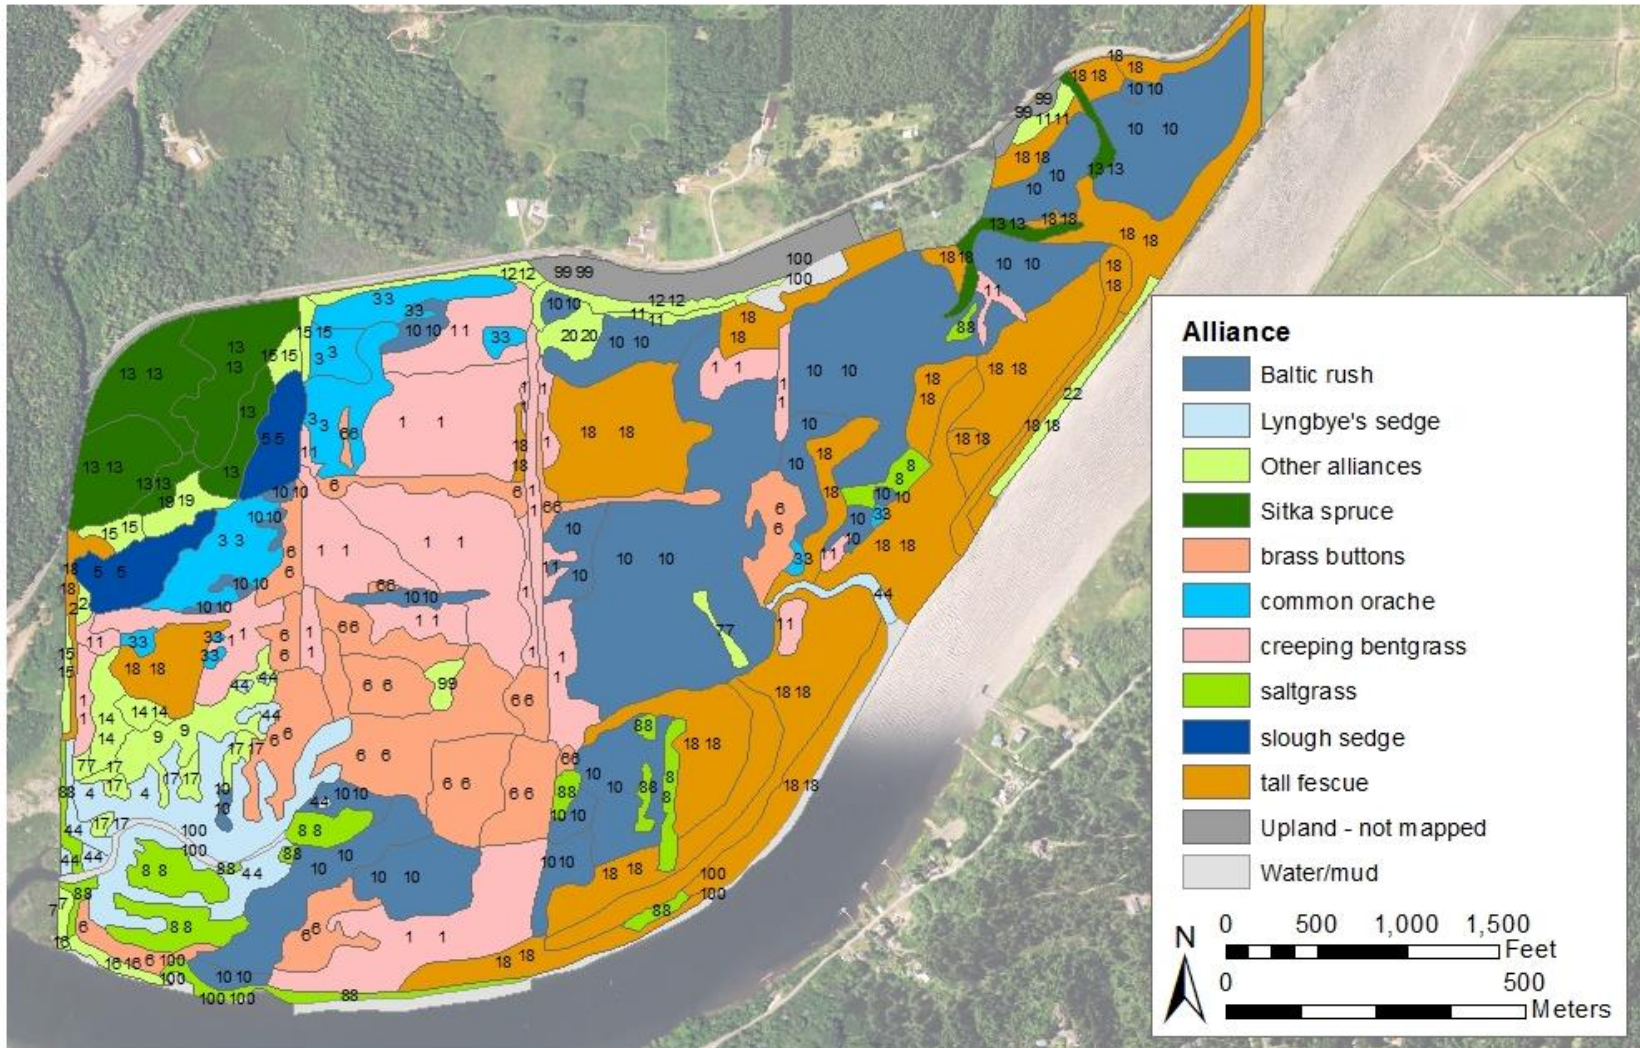
Figure 24. Plant communities at Ni-les'tun in 2015, colored by alliance. Blue/green tones indicate native alliances; orange/pink indicates non-native. Labels show alliance numbers (see Appendix 2, Table A2-1).

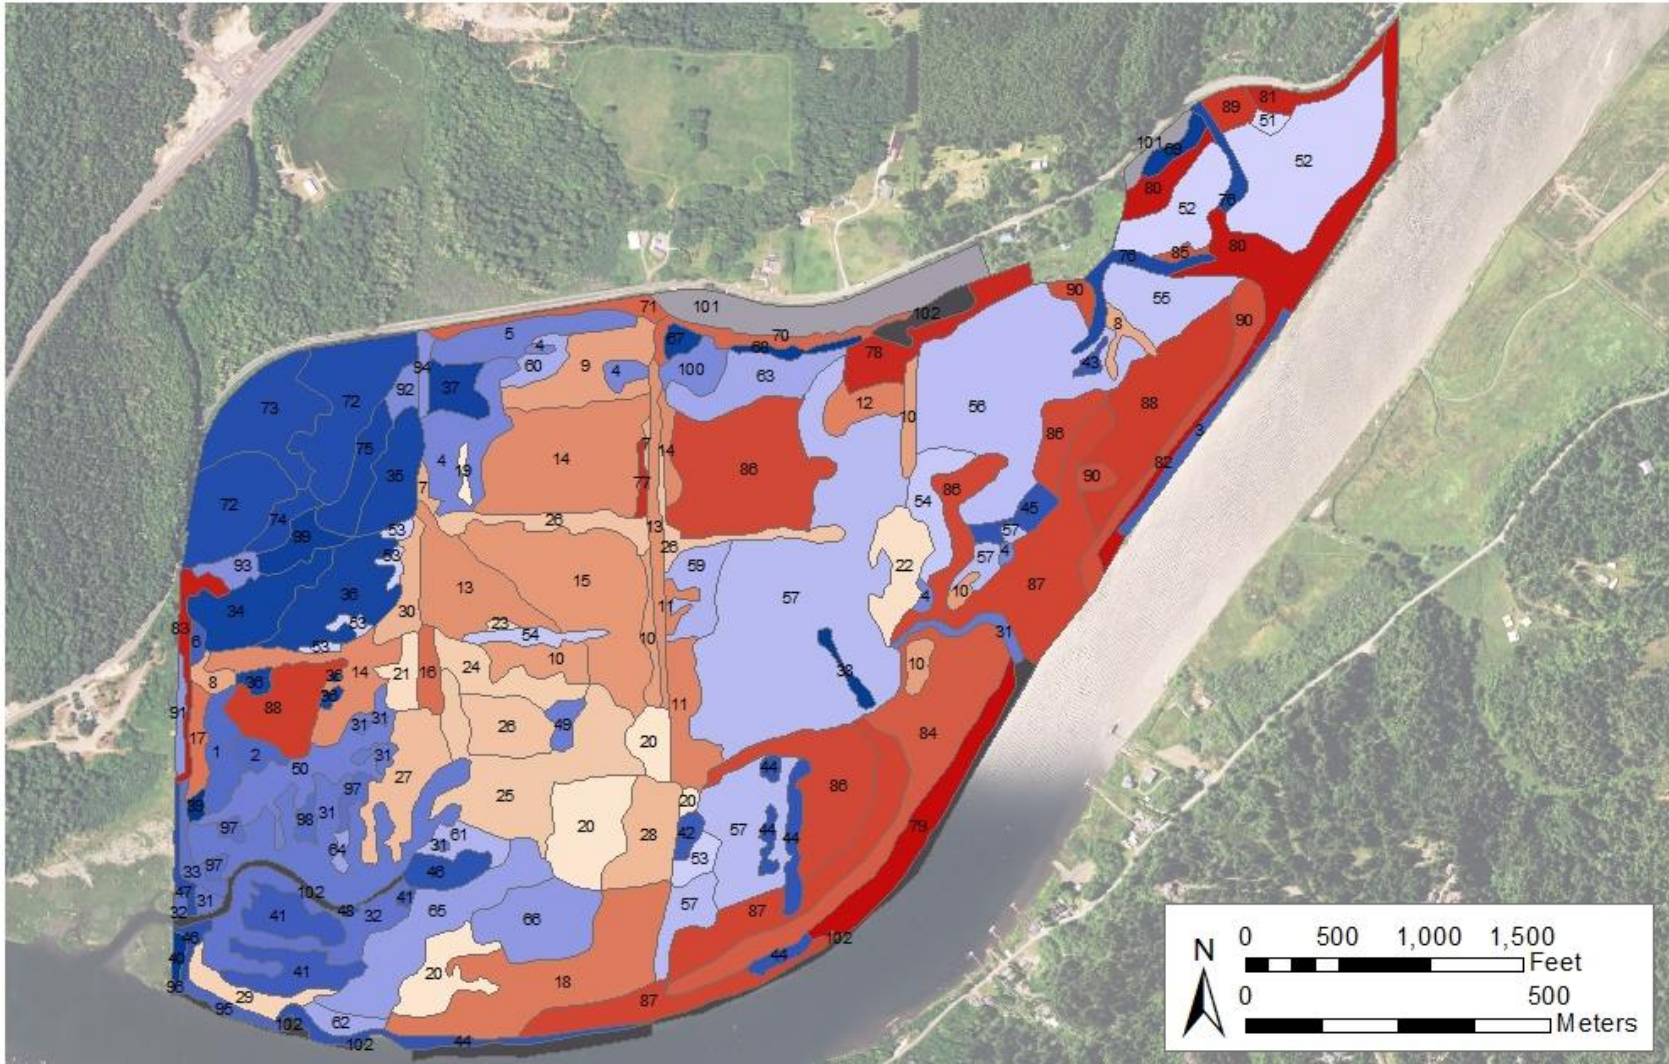
Figure 25. Plant communities (associations) at Ni-les'tun in 2015. Related associations are colored similarly. Blue tones indicate native-dominated associations; orange/red tones indicate non-native. Labels show association numbers (see Appendix 2, Table A2-2).
