Wetland Site Prioritization

Lower Elk and Sixes Rivers, Curry County, OR

July 2003

Laura Brophy
Green Point Consulting
Corvallis, OR 97330

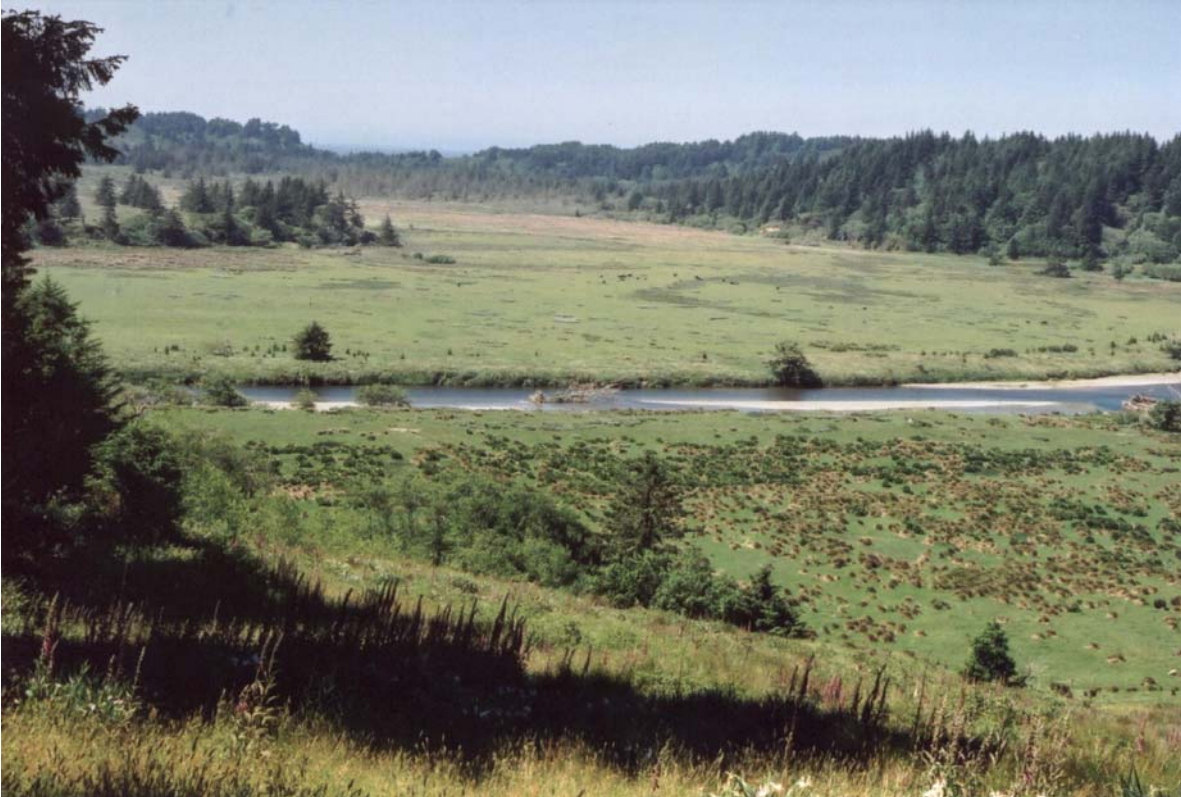
Site S2 (foreground) and Site S4 (Sullivan's Gulch, background), separated by the Sixes River, near Cape Blanco, Oregon, June 2002. Photo by L. Brophy.

The eastern portion of Site S2 presents a rare sight – an actively grazed alluvial terrace with high cover of tall, vigorous skunk cabbage. 1939 photos indicate that this area was probably spruce swamp prior to logging. The presence and condition of the skunk cabbage indicates that wetland hydrology is definitely still present. A grazing setaside here, along with spruce plantings, would probably allow very rapid recovery of a vegetation type that is now quite rare in the study area and on the Oregon coast in general. Since the landowner reports that juvenile salmon use the next drainage east (on
