**SUBJECT: 2014 Monitoring Report for Tamara Quays Project**

## 2014 Monitoring Report: Tamara Quays Tidal Wetland Restoration

**December 1, 2014**

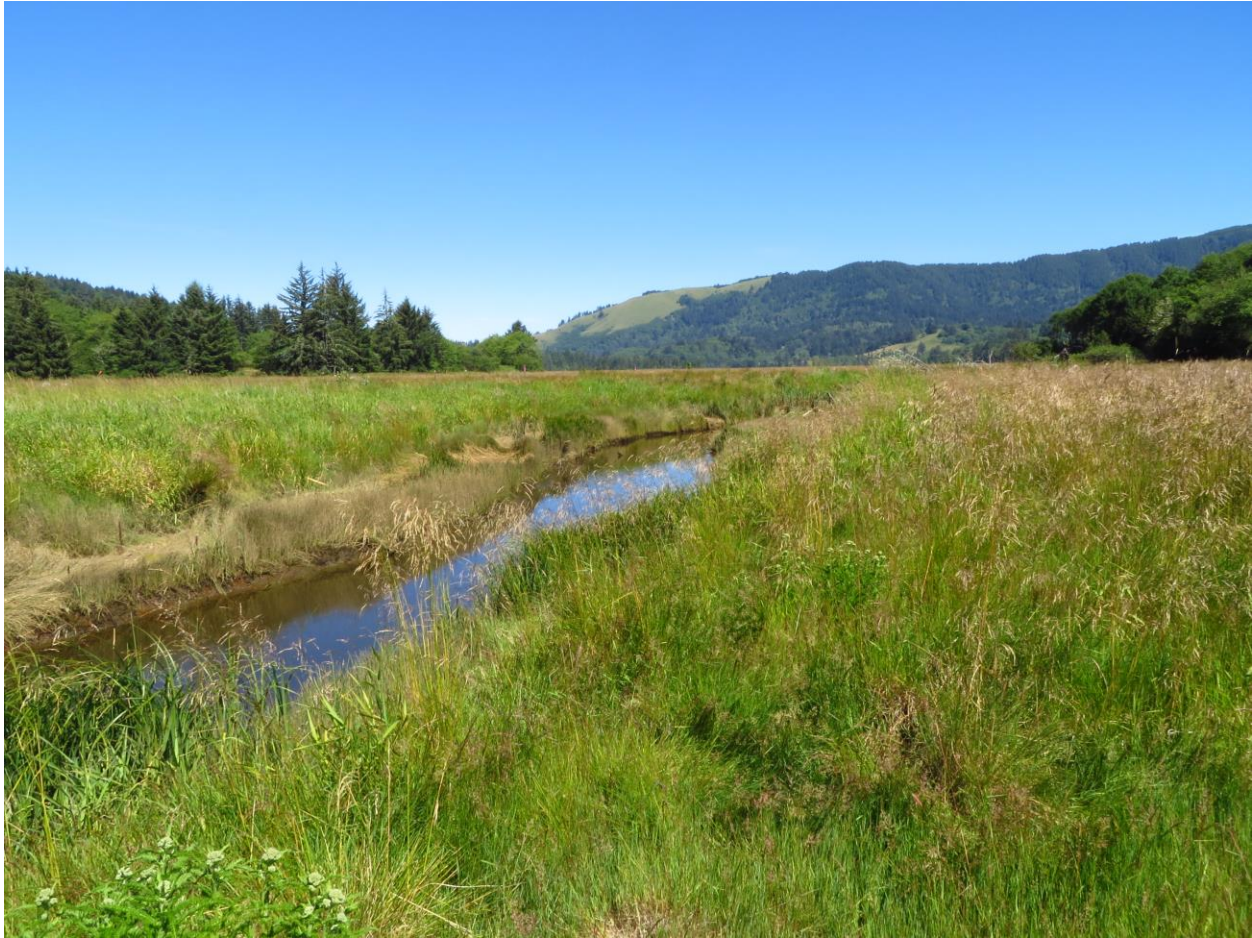
Tamara Quays restoration site: Rowdy Creek channel below former Kingfisher Lake, 7/1/14. Photo by L. Brophy.

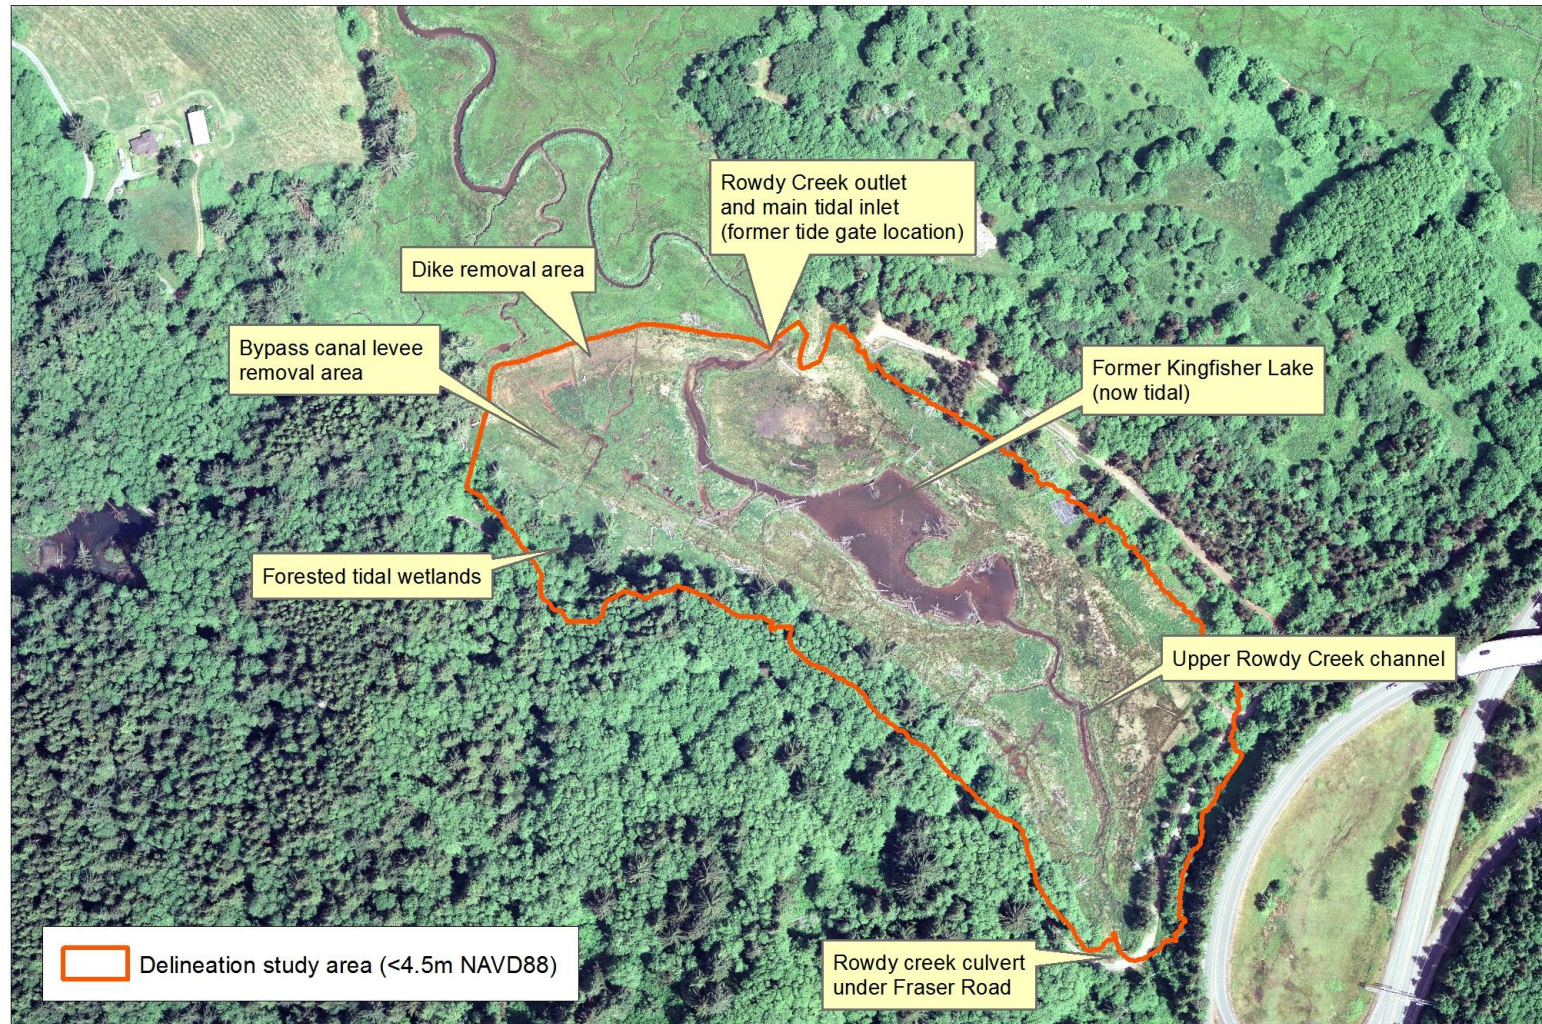
Map 2. 2014 Post-project wetland delineation study area and site features

Tamara Quays: Wetland delineation study area (18.4 A) and site features  
Background: USFS 2012 orthophoto

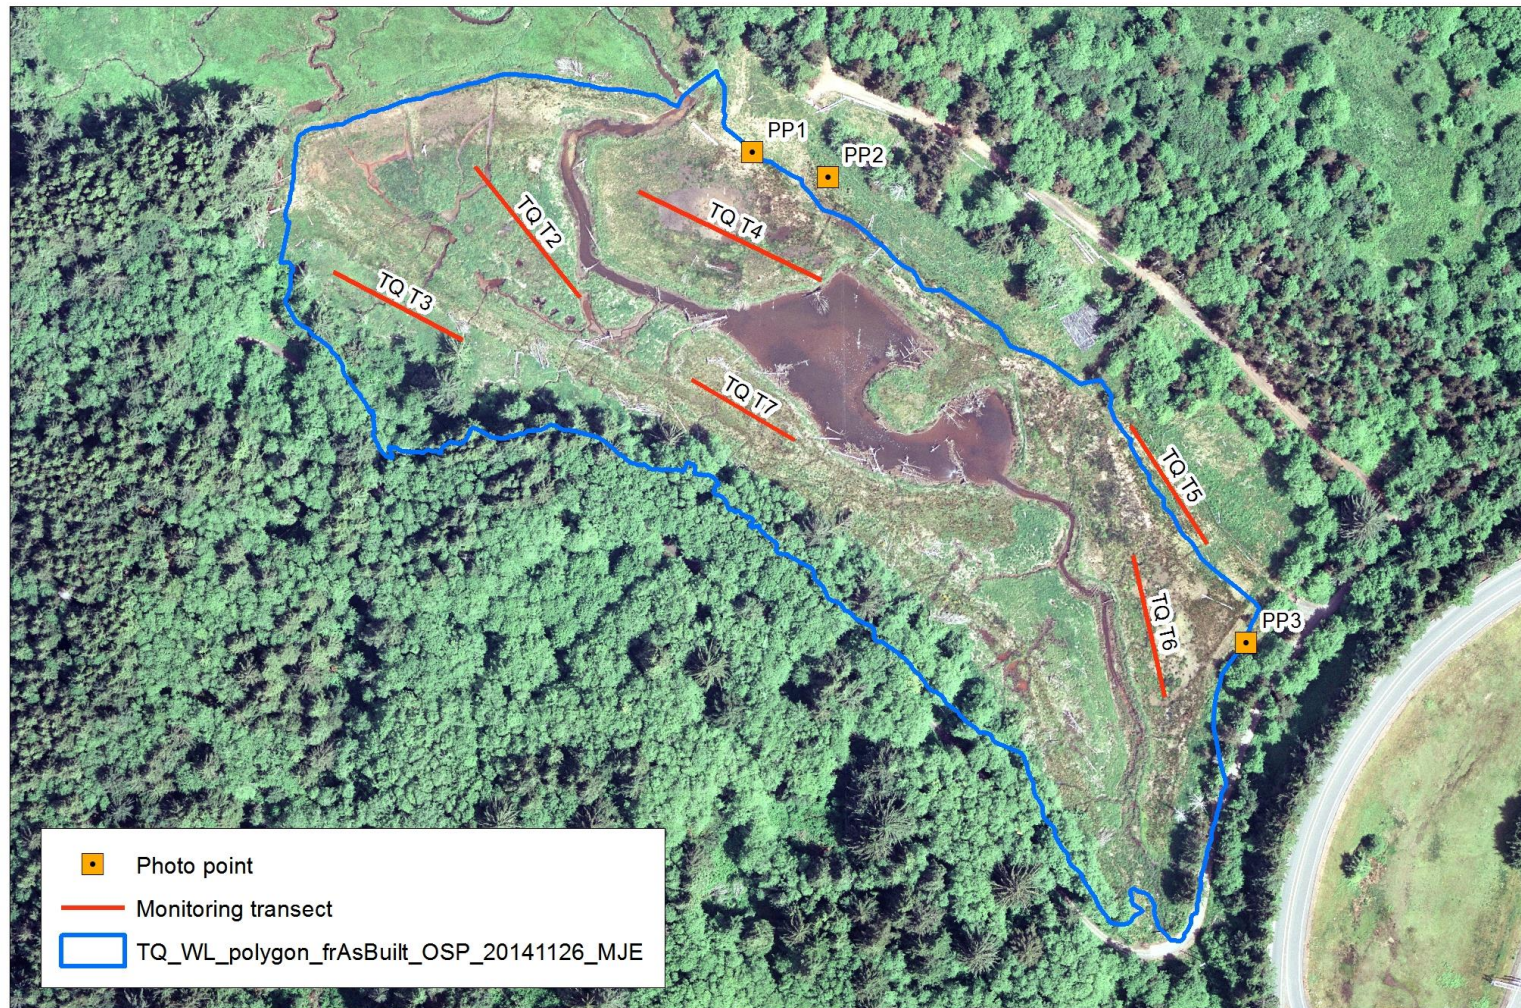
Map 4. Monitoring transects and photo points. Photo points are included in the wetland delineation report (Appendix 7).

Tamara Quays: Monitoring transects and photo points. Blue line is wetland boundary.  
Background: USFS 2012 orthophoto

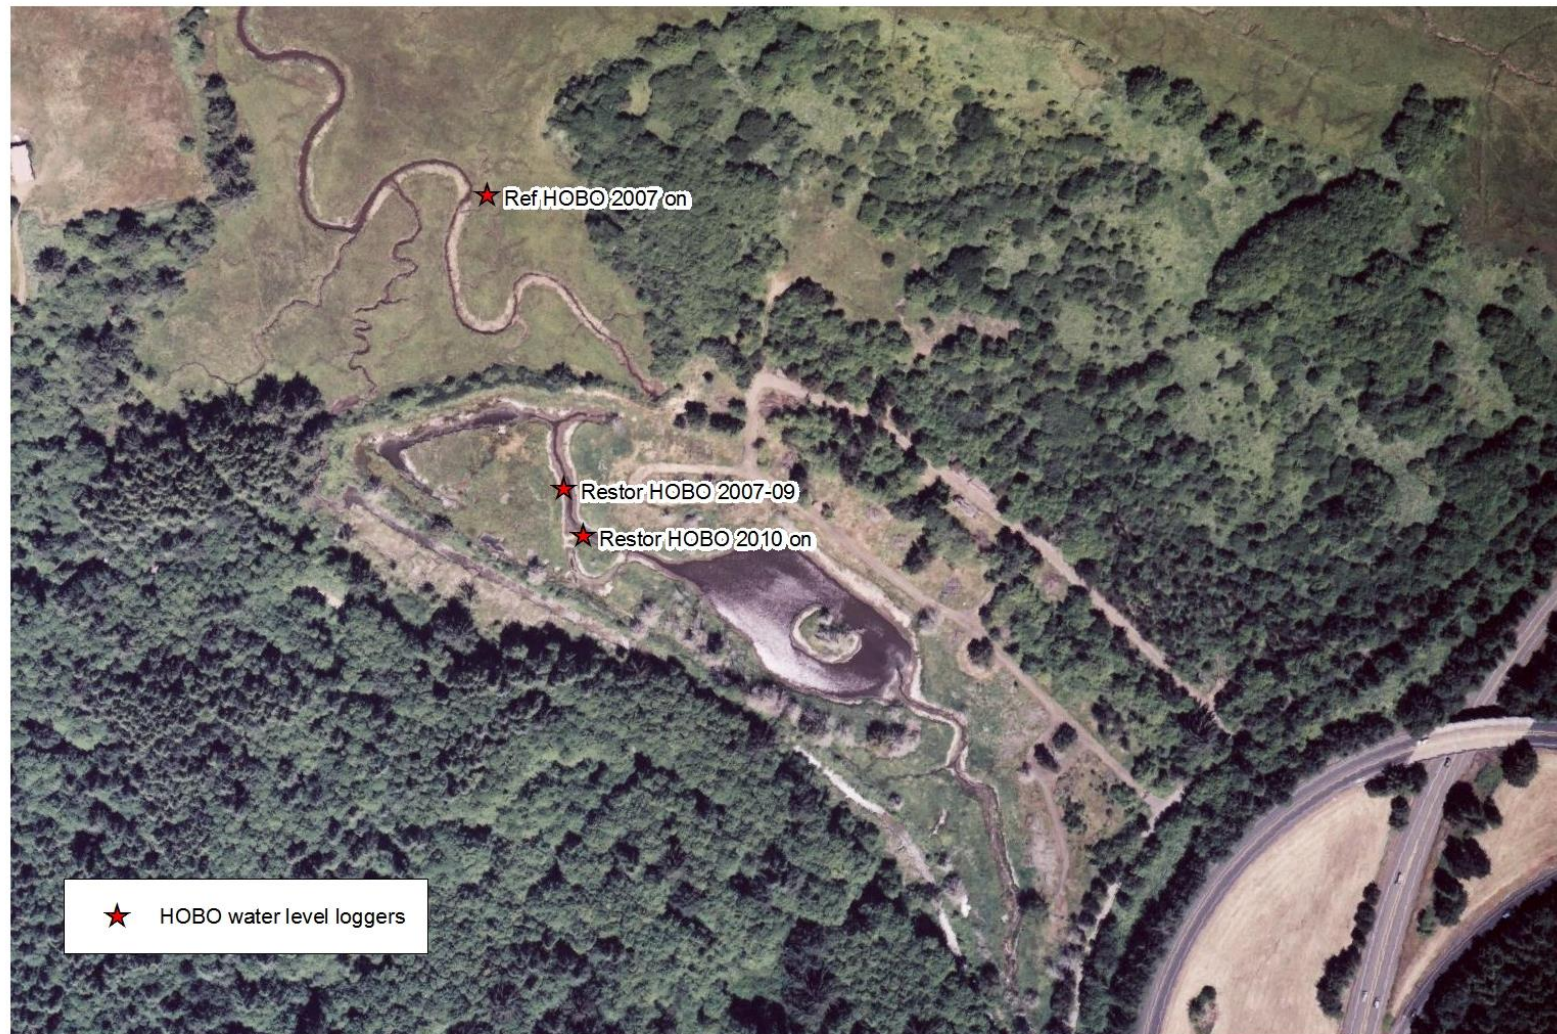
## Map 7. Water level logger locations

Tamara Quays: Locations of HOBO water level loggers, 2007-2010  
Background: USFS 2008 aerial orthophoto (pre-restoration image)

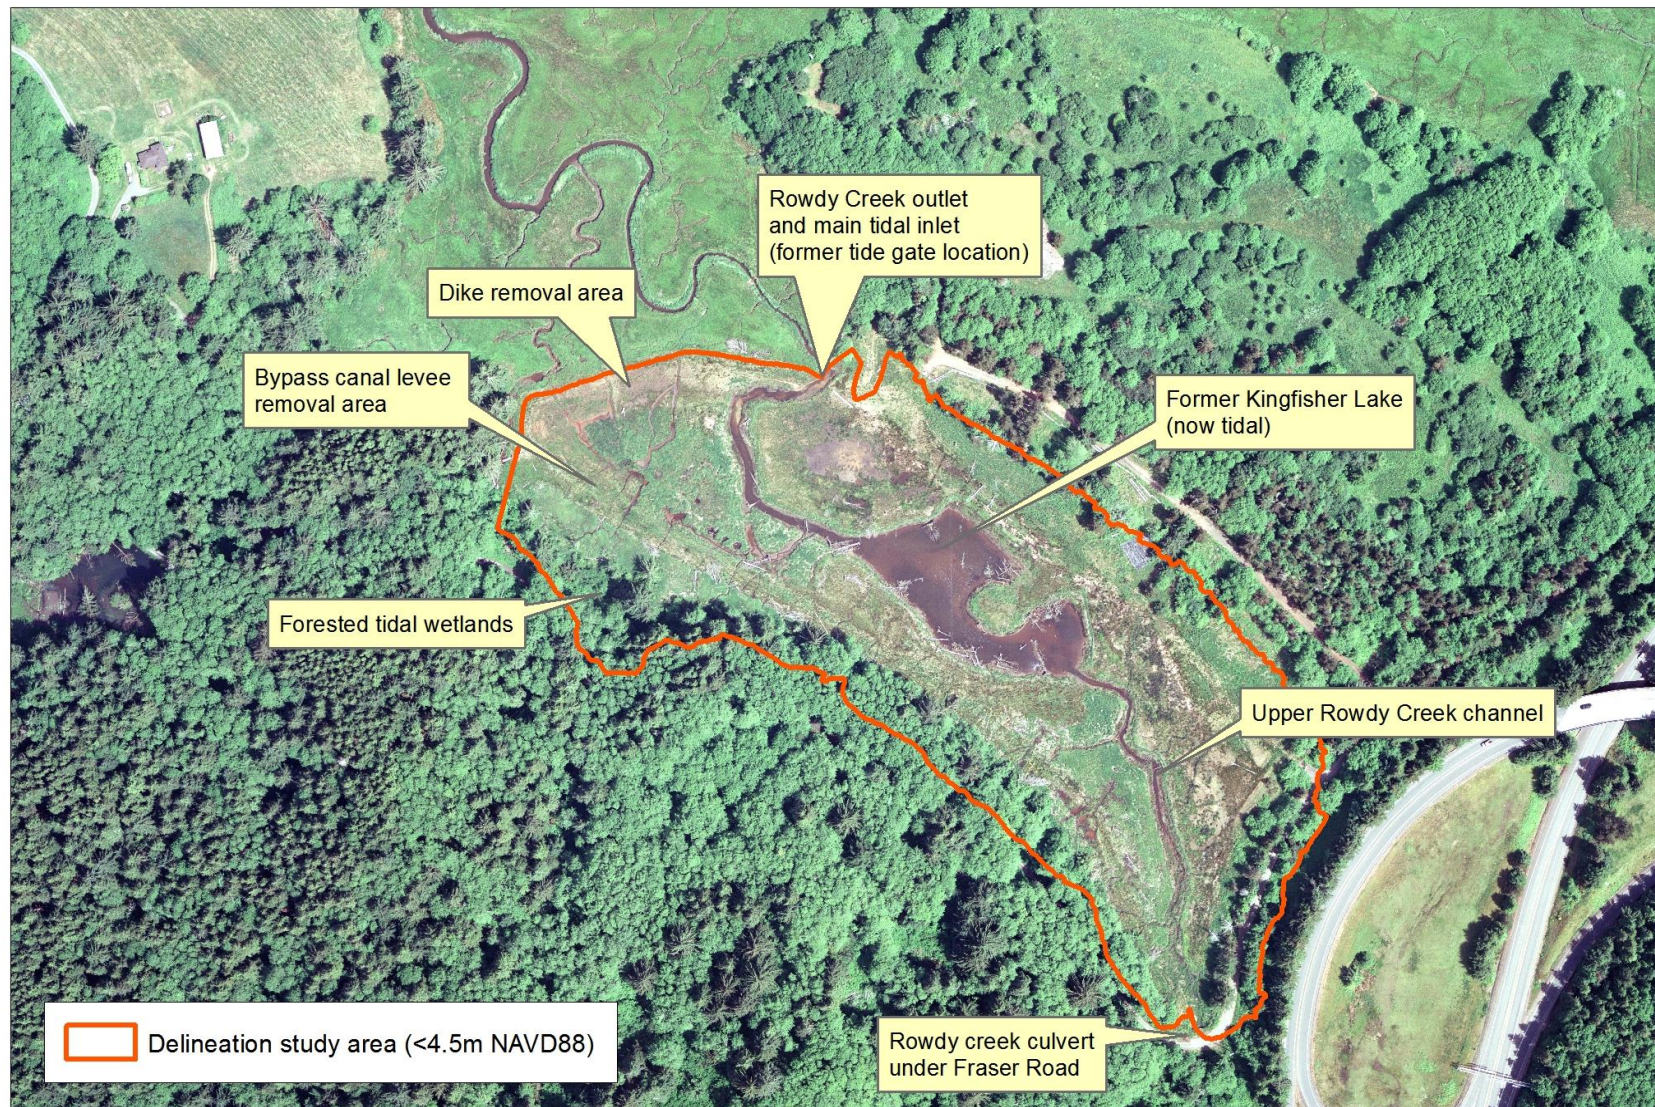
## Map W2. Study area boundary and site features

### Tamara Quays: Wetland delineation study area (18.4 A) and site features Background: USFS 2012 orthophoto

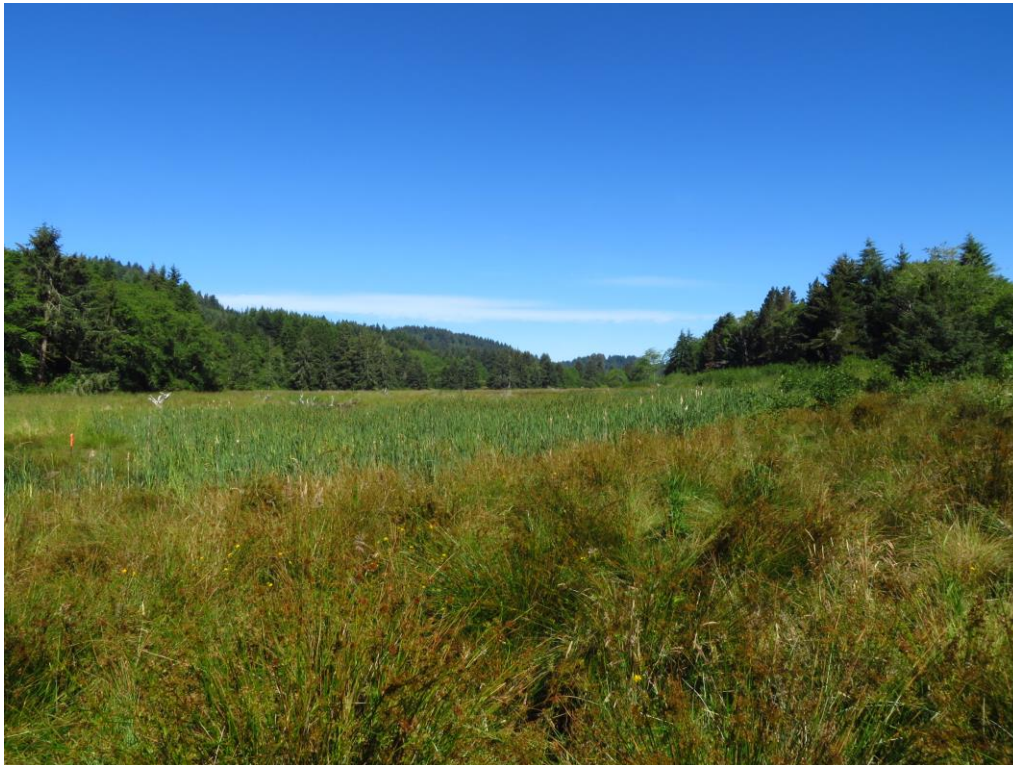
Photo 8. Typical soft rush (foreground) and common cattail (background) communities in high tidal marsh at Tamara Quays, 7/1/14. Photo was taken near effectiveness monitoring transect TQ T5, looking northwest.

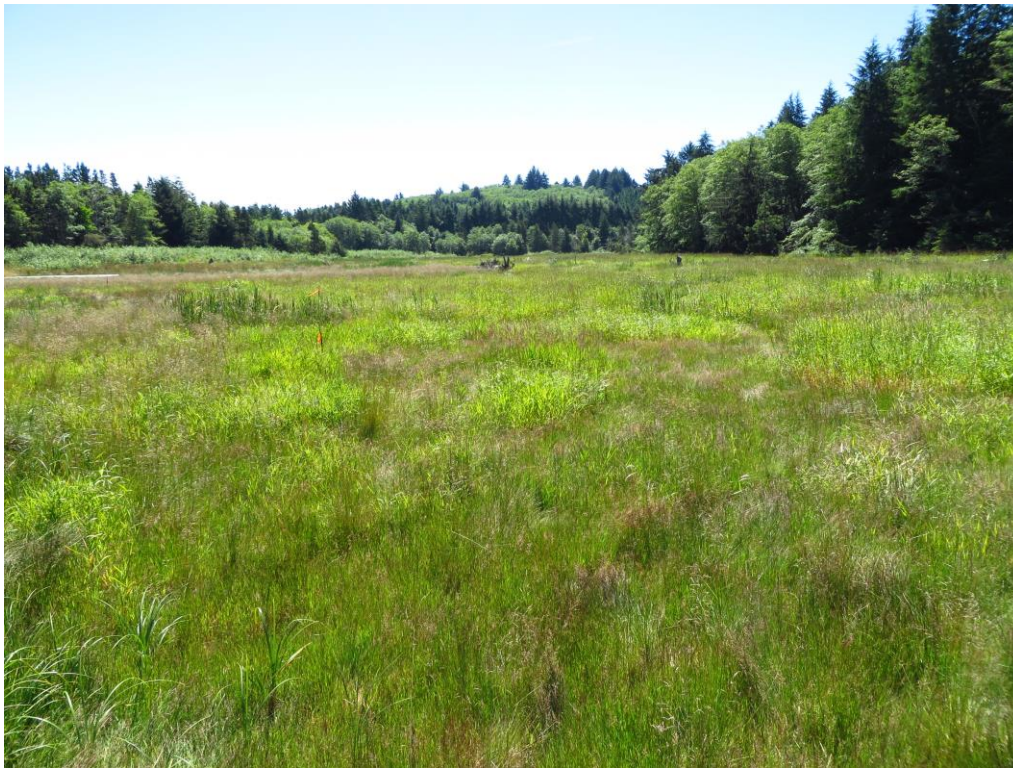
Photo 9. Creeping bentgrass – Baltic rush brackish tidal marsh association, ungraded area in northwest portion of Tamara Quays, 7/1/14. Photo was taken from the former dike location looking southeast towards effectiveness monitoring transect TQ T2.

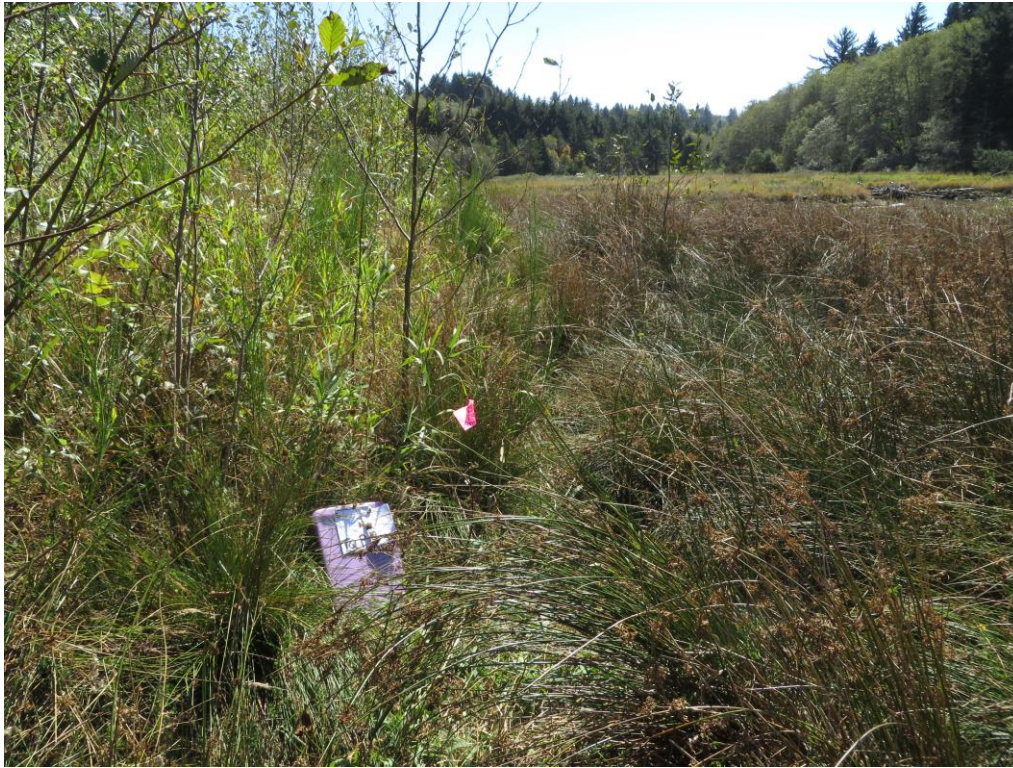
Photo 11. Photo Point 2 (PP2 in Map W5), looking SE along the hydrophytic vegetation boundary. The primary wetland boundary is downslope to the right, in dense *Juncus effusus*.

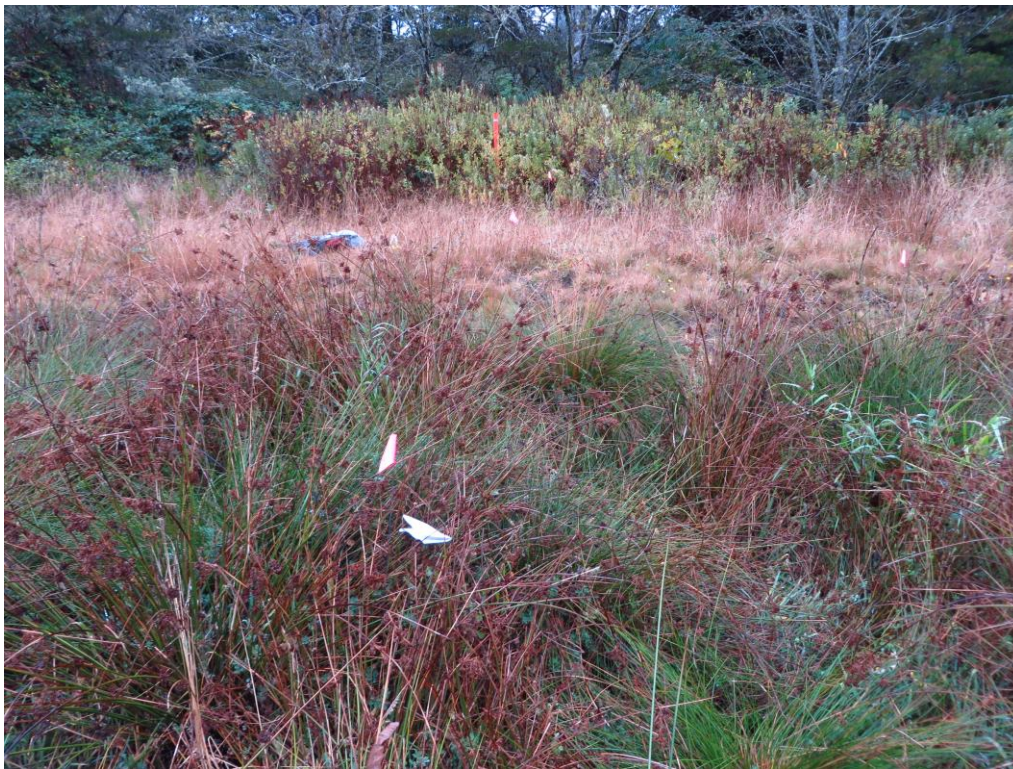
Photo 12. Photo Point 3 (PP3 in Map W5), looking east along transect TQ T2, 9/23/14. TQ T2 P1 is in the foreground. The primary wetland boundary is in the light band of grassy vegetation in the middle ground.
