Waite Ranch Baseline Effectiveness Monitoring: 2014

March 9, 2015

Prepared by:
Laura S. Brophy, Laura A. Brown, and Michael J. Ewald
Estuary Technical Group, Institute for Applied Ecology, Corvallis, Oregon

Prepared for:
Siuslaw Watershed Council, Mapleton, Oregon

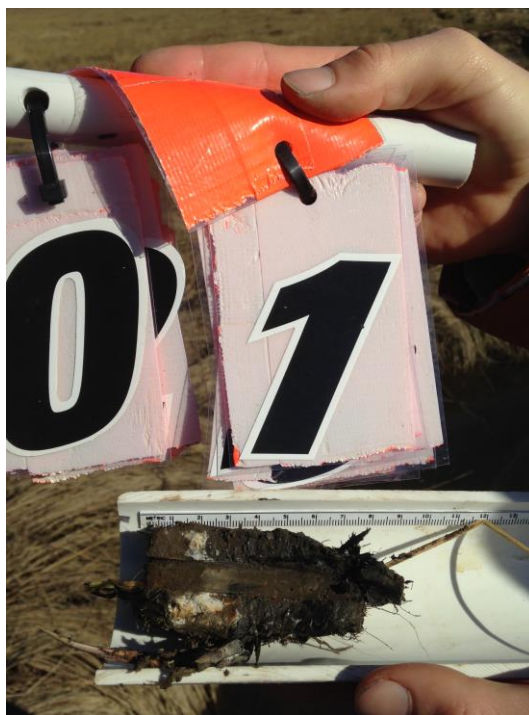
Photo 1. Photo of feldspar marker horizon method. Sediment to the left of the white feldspar marker horizon has been deposited over the past year.

Feldspar is a white-colored mineral that is recommended as a marker horizon, as it is usually easy to distinguish the white material from dark soils (Cahoon *et al.* 2000). In November 2013, a layer of feldspar was spread over a 0.25 m² area in the center of a larger demarcated plot (1 m²). The feldspar layer thickness was about 5 to 15 mm. The corners of the 1 m² plot were marked with PVC poles to reduce human trampling of plots. A year later, in 2014, we returned to the plots with a pressurized canister (“Dewar”) filled with liquid nitrogen. The liquid nitrogen was used to sample two cores at each plot using the “cryo-coring” method (Cahoon *et al.* 1996). Four replicate measurements of the amount of material accreted (distance from top of soil to top of feldspar layer) were taken for each core (Photo 1). The core was then placed back into the ground. Core locations within the quadrat were recorded to ensure those areas would not be re-sampled in future years of monitoring.

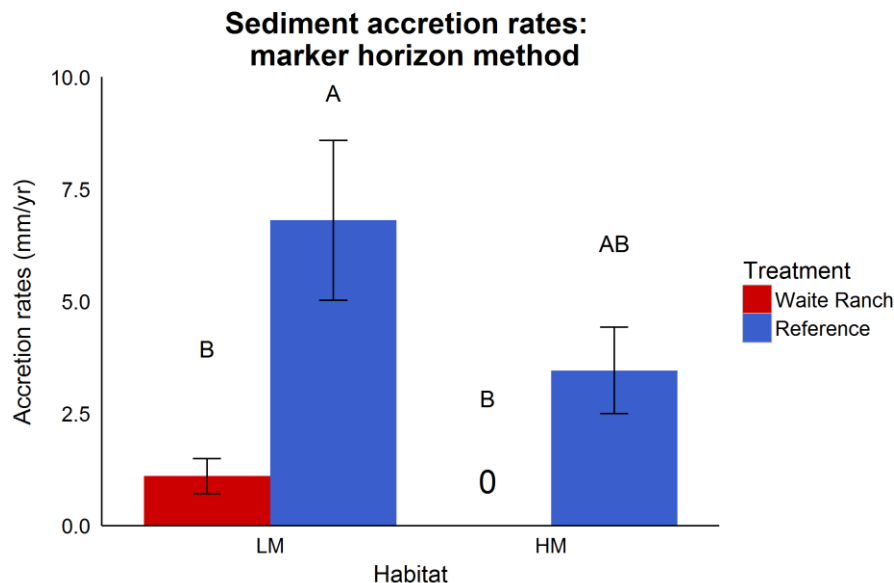
Figure 12. Sediment accretion rates at Waite Ranch and reference sites (Cox Island and S30), within low marsh (LM) and high marsh (HM) elevation categories (below and above MHHW respectively), using the marker horizon method. Only one plot at Waite Ranch fell in the high marsh category; it had no measured accretion. Columns with no letters in common are significantly different (two-way ANOVA, $p < 0.05$). Error bars represent one standard error.

When evaluated across all sites (Waite Ranch and reference sites), accretion was lower in high marsh and higher in low marsh; however, the difference was not significant (Table 14 and 15). Restoration of the natural sediment regime at Waite Ranch will allow sediment to enter the site during daily tides and during river flood events. Newly recruited native plants species will trap sediment drifting through the water column, allowing more sediment to be retained (Borde *et al.* 2011). After restoration, we expect low marsh at Waite Ranch to have higher rates of sediment accretion compared to the high marsh. This is due to the higher inundation frequency and consequently higher sediment inputs for low marsh, compared to high marsh (Borde *et al.* 2011).

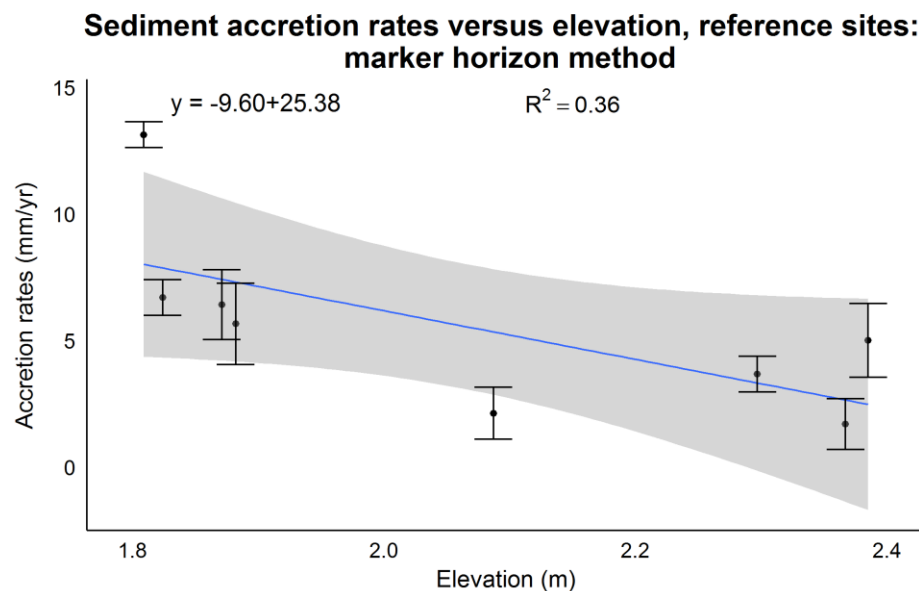
Figure 13. Accretion rates along an elevation gradient for all plots at reference sites on Cox Island and S30 using the marker horizon method. The gray region is one standard error from the predicted line. Error bars represent one standard error for each point.

Consistent with the general pattern of higher rates of accretion in low marsh and lower rates in high marsh, linear regression showed a significant relationship between elevation and sediment accretion rates at the reference sites (Figure 13; Table 16). That is, the accretion rate was higher at lower elevations than at higher elevation. This relationship is consistent with tidal wetland development models (Allen 1990) and observations by others on the West Coast (e.g. Thom 1992, Simenstad and Thom 1996, Borde *et al.* 2011). The relationship between accretion rate and elevation was much less clear at Waite Ranch (Figure 14; Table 16). Figure 15 shows the amount of sediment accretion in each plot, ordered by elevation, showing the lack of relationship between elevation and accretion rates at Waite Ranch. This lack of relationship is due to the fact that Waite Ranch is currently disconnected from tidal and fluvial sediment sources by its dike and tide gate. Because of this disconnection, natural elevational gradients in sediment deposition rates are disrupted. Once Waite Ranch is restored, we expect to see accretion rates follow a pattern similar to the reference sites, with higher accretion at lower elevations.

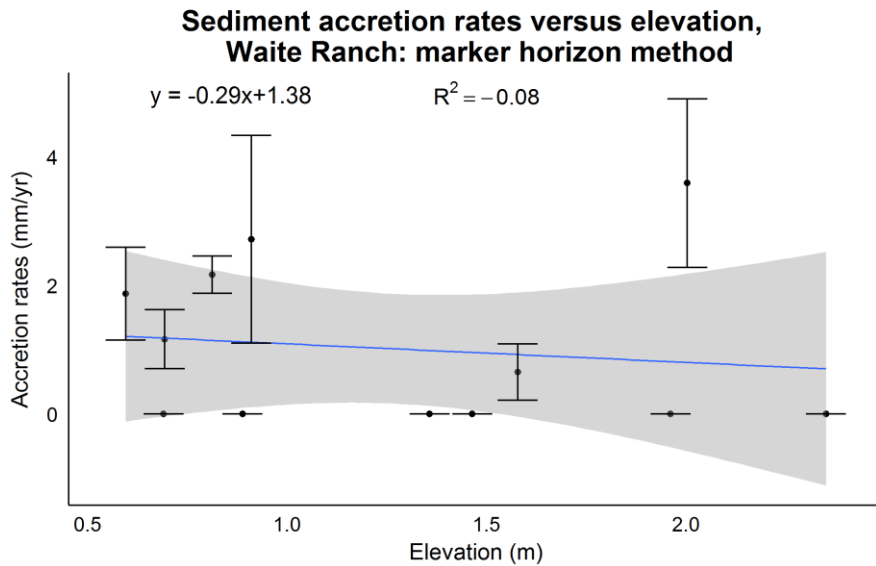
Figure 14. Accretion rates along an elevation gradient for all plots at Waite Ranch using the marker horizon method. The gray region is one standard error from the predicted line. Error bars represent one standard error for each point.

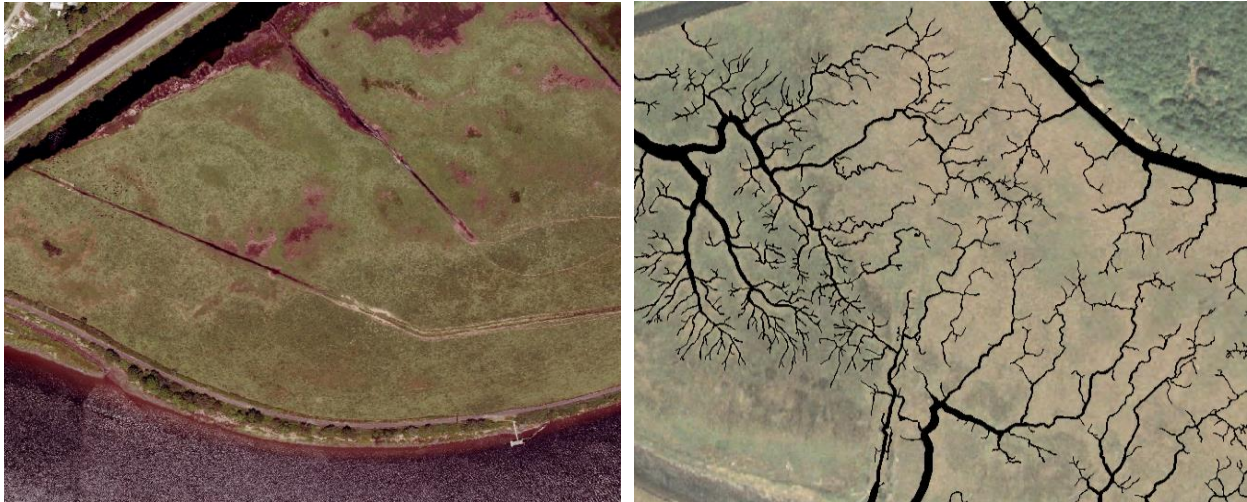
Figure 16. Channel network density comparison. **Left:** simplified channel (ditch) network in a 75 acre section of Waite Ranch. Channel density is about 0.02 mi/acre; channel length is about 1 mi. **Right:** dense, dendritic channel network in a 75 acre section of least-disturbed tidal marsh (Millport Slough, Siletz Bay NWR, surveyed by So *et al.* (2009). Channel density is about 0.15 mi/acre; channel length is about 11 mi. Figure from Brophy and Lemmer (2013).

Agricultural use and ditching at Waite Ranch have greatly decreased overall channel length, density, and sinuosity. The decrease is obvious through visual comparison to Cox Island (Figures 2 through 5). Quantitative comparison to the complete survey of least-disturbed tidal channels at Siletz Bay NWR (So *et al.* 2009) shows that ditching has reduced channel density by 87% (to only 13% of the Siletz site's density), and has reduced channel length by 91% (to only 9% of the Siletz site's length) (Figure 16). Sinuosity is near zero for Waite Ranch (*i.e.*, the site's ditches are straight), compared to sinuosities of 1.5 to 2.0 for middle-order channels at the Siletz Bay site (So *et al.* 2009).

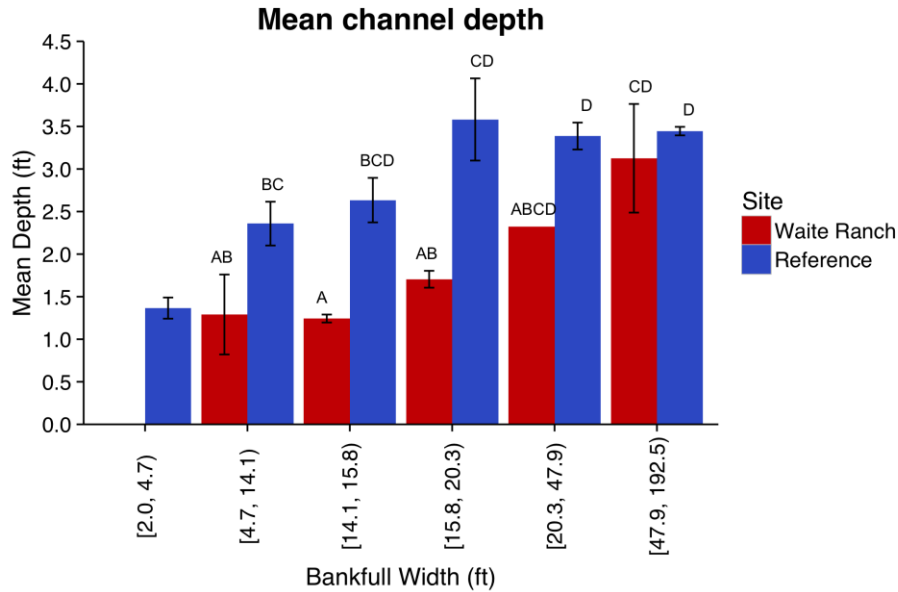
Figure 17. Mean channel depth by BFW class for Waite Ranch and reference sites (Cox Island and S30). Bars with no letters in common are significantly different ($p < 0.05$). Error bars represent one standard error. The smallest channels (*i.e.*, “[2.0, 4.7]”) were excluded from the statistical analysis.

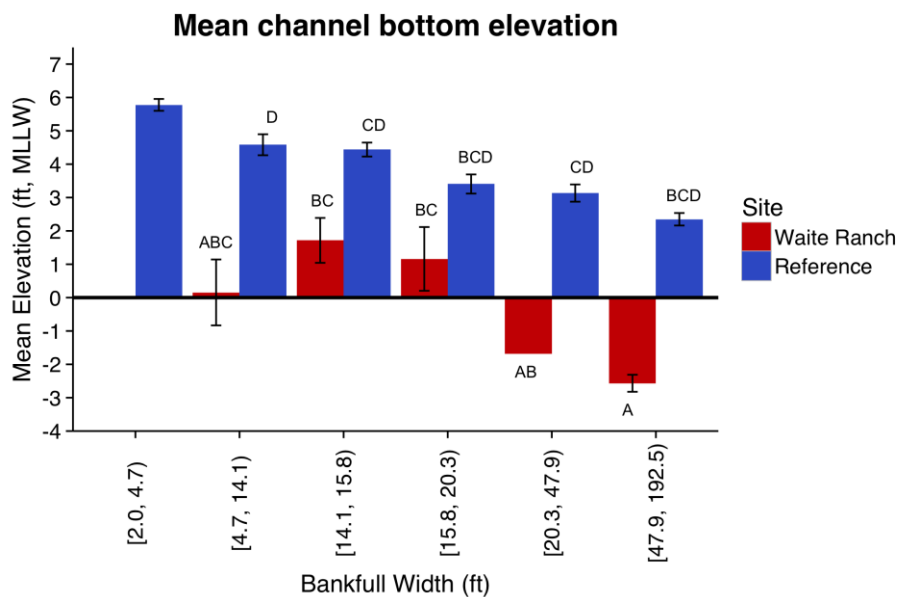
Figure 18. Mean channel bottom elevation by BFW class for Waite Ranch and reference sites (Cox Island and S30). Bars with no letters in common are significantly different ($p < 0.05$). Error bars represent one standard error. The smallest channels (*i.e.*, “[2.0, 4.7]”) were excluded from the statistical analysis.

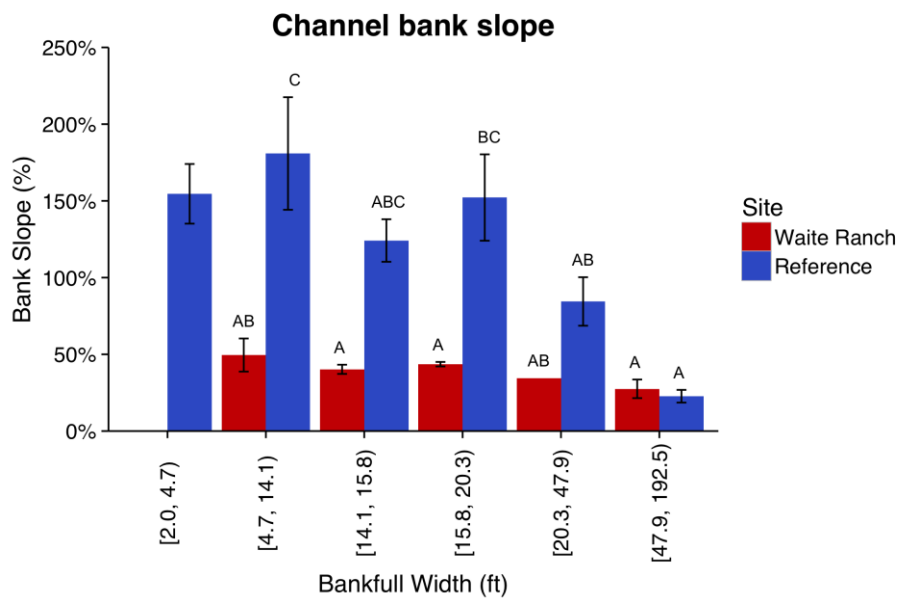
Figure 19. Channel bank slope by BFW class for Waite Ranch and reference sites (Cox Island and S30). Bars with no letters in common are significantly different ($p < 0.05$). Error bars represent one standard error. The smallest channels (*i.e.*, “[2.0, 4.7]”) were excluded from the statistical analysis.

In agricultural sites such as Waite Ranch, our field experience suggests the bank slope will be shallower than at reference sites. Machinery, livestock, and subsidence cause banks to slump and become degraded. At Waite Ranch, the average bank slope of the channels was 40% -- significantly less steep than reference site channels, which had a mean bank slope of 104% (Tables 23 and 24). The significance of the slope difference varied between BFW classes, but all BFW classes except the largest showed the same relationship (Waite Ranch bank slopes were much shallower) (Figure 19, Table 25). There was a significant interaction between site and BFW class (Table 23), showing that the relationship between restoration and reference site bank slopes varied by BFW class: specifically, the widest BFW class showed little difference in bank slope.

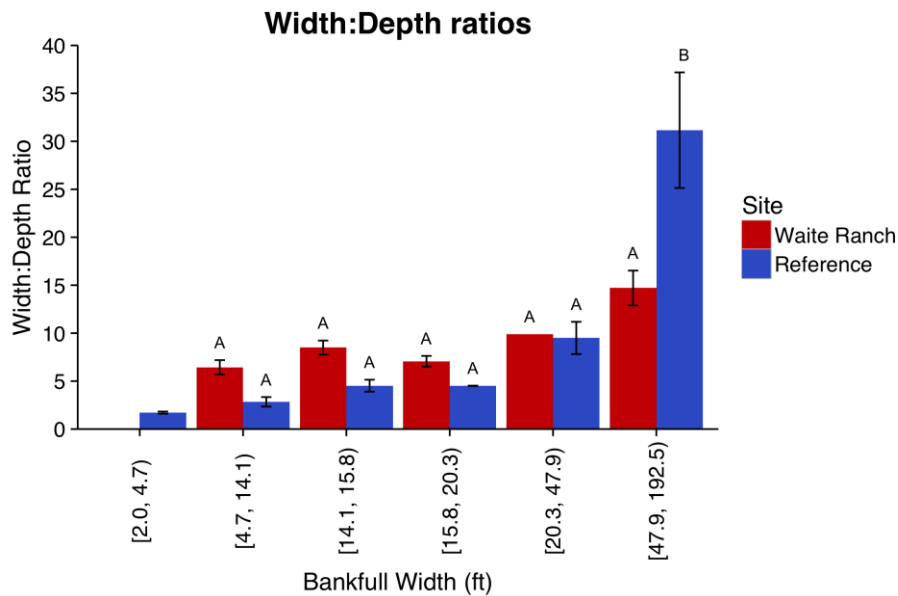
Figure 20. WTD ratios by BFW class for Waite Ranch and reference sites (Cox Island and S30). Bars with no letters in common are significantly different ($p < 0.05$). Error bars represent one standard error. The smallest channels (*i.e.*, “[2.0, 4.7]”) were excluded from the statistical analysis because they were absent at Waite Ranch.

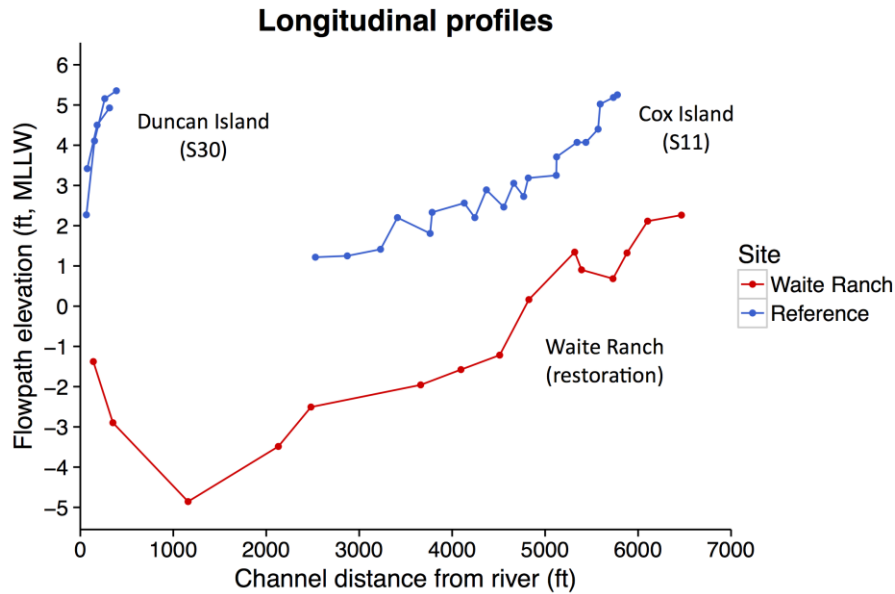
Figure 22. Longitudinal profiles for Waite Ranch and reference sites (Cox Island and S30). Each profile shows a rapid gain in elevation in channels higher in the landscape. S30 shows a particularly short channel network, corresponding to its small drainage area.

Longitudinal profiles describe the tidal elevation of the lowest part of the channel, from channel mouth to headwaters. Instead of only measuring elevation, profiles reveal dips and peaks within the flowpath. Figure 22 shows the shape of the longitudinal profile of each channel network from the mouth of the channel network (junction with the Siuslaw River) up to the highest channel morphology transect. Waite Ranch and Cox Island (S11) had similarly low gradients (under 0.5%) for most of their length. However, the gradient rose (to around 1%) in the smaller “headwaters” channels at Cox Island. S30 (Duncan Island) had a relatively high gradient throughout the small channel network, closely resembling the Cox Island channel network near 5,500 ft from the channel mouth. The rapid transition appears to begin at a channel bottom elevation of approximately 3 ft MLLW at both Cox Island and S30, in the high marsh zone. The entire length of the measured channel at S30 is in high marsh, which may explain its consistently high gradient (around 1%); other factors include the small size and resulting small drainage area. Our work at other least-disturbed high marsh sites near Bandon and Tillamook, OR has documented similar patterns (Estuary Technical Group, unpublished; Brophy *et al.* 2014). Relationships between channel network characteristics (length, density, area, gradient, etc.) and site characteristics (area, elevation, landscape setting, etc.) have been explored by Hood (2002, 2007, 2014), Coats *et al.* (1995), Williams *et al.* (2002), and others.

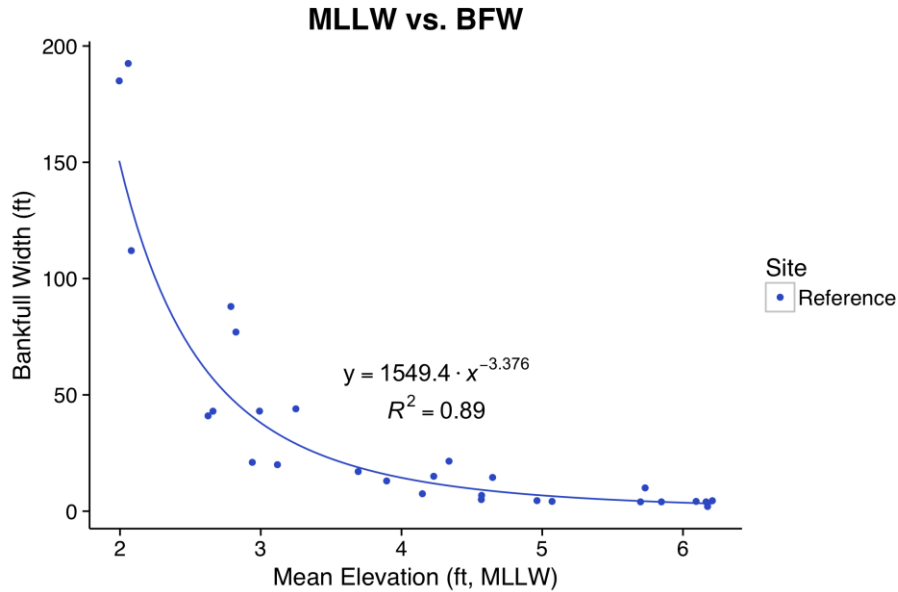
Figure 23. Bankfull width as a function of tidal elevation at Cox Island and S30 reference sites

Our results at Waite Ranch and nearby reference sites (Cox Island and S30) provide insight into potential relationships between tidal elevation and various channel morphology metrics that may aid restoration channel design (Williams *et al.* 2002). One important relationship was between tidal elevation and BFW. Figure 23 shows the exponential relationship between BFW and MLLW at reference sites.

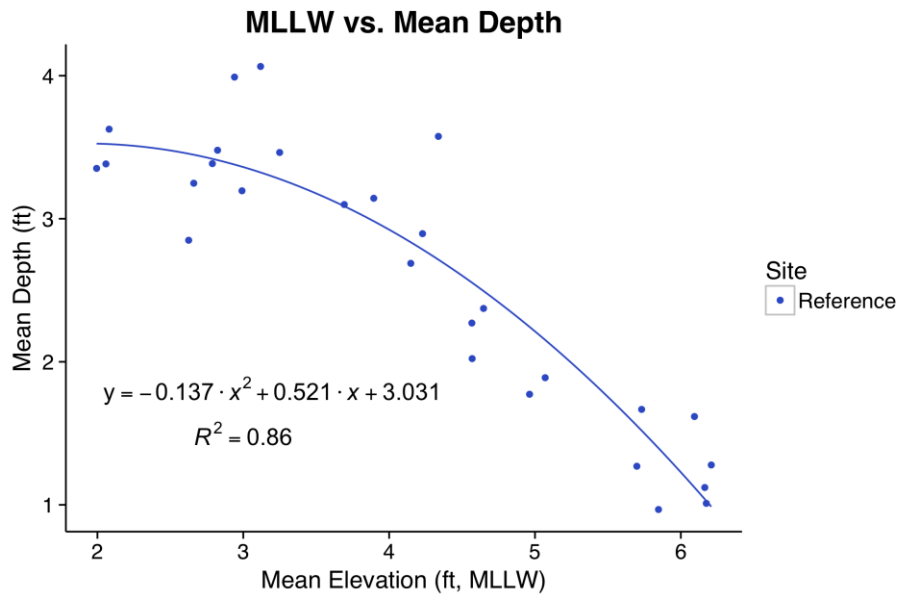
Figure 24. Channel depth (relative to top of bank) as a function of tidal elevation at Cox Island and S30 reference sites.

There was also a strong relationship between tidal elevation and mean channel depth. As elevation in the tide frame was reduced, mean channel depth increased (Figure 24).

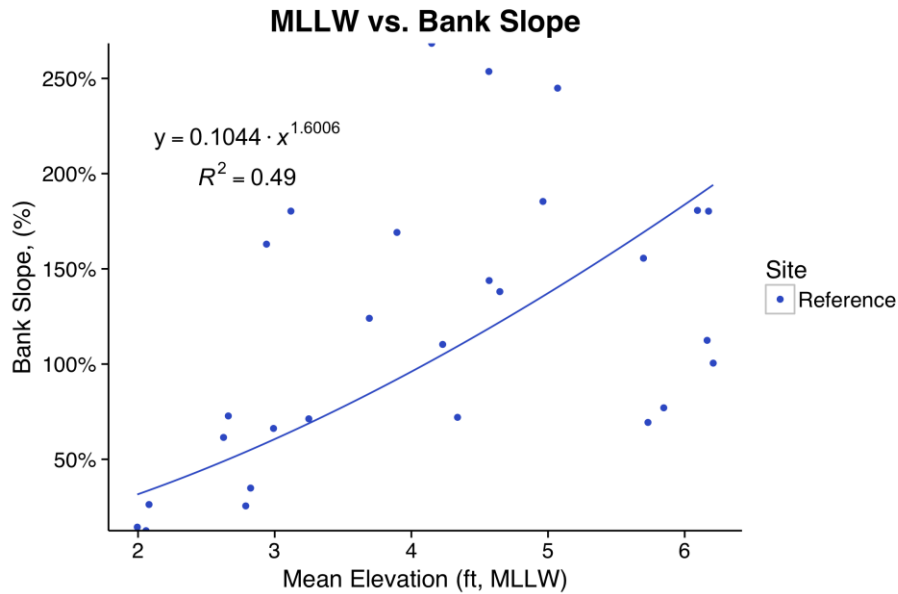
Figure 25. Channel bank slope as a function of tidal elevation at Cox Island and S30 reference sites.

The relationship between tidal elevation and bank slope was noisy and likely not informative for engineering new channels. However, as elevation in the tide frame increased, bank slope appears to also increase (Figure 25).

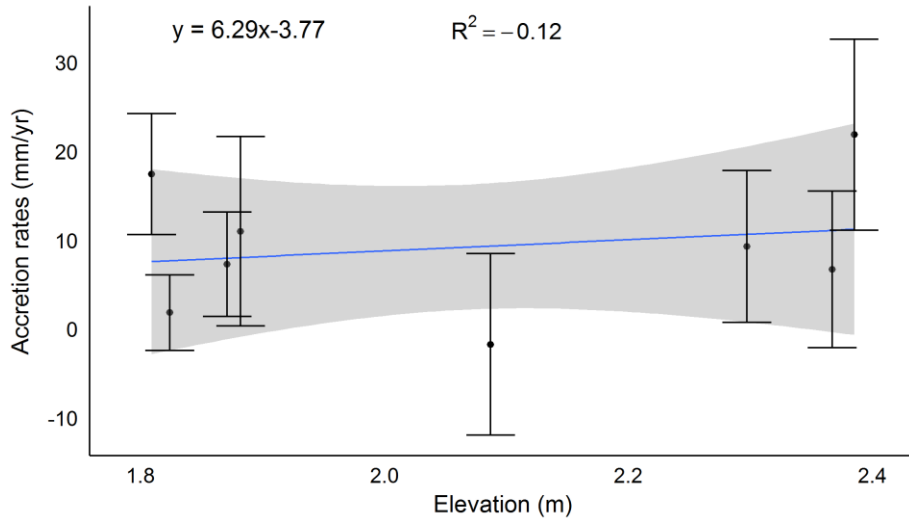
Figure A2.5. Accretion rates along an elevation gradient for all plots for reference sites on Cox Island and S30 using the sediment stake method. The gray region is one standard error from the predicted line. Error bars represent one standard error for each point.

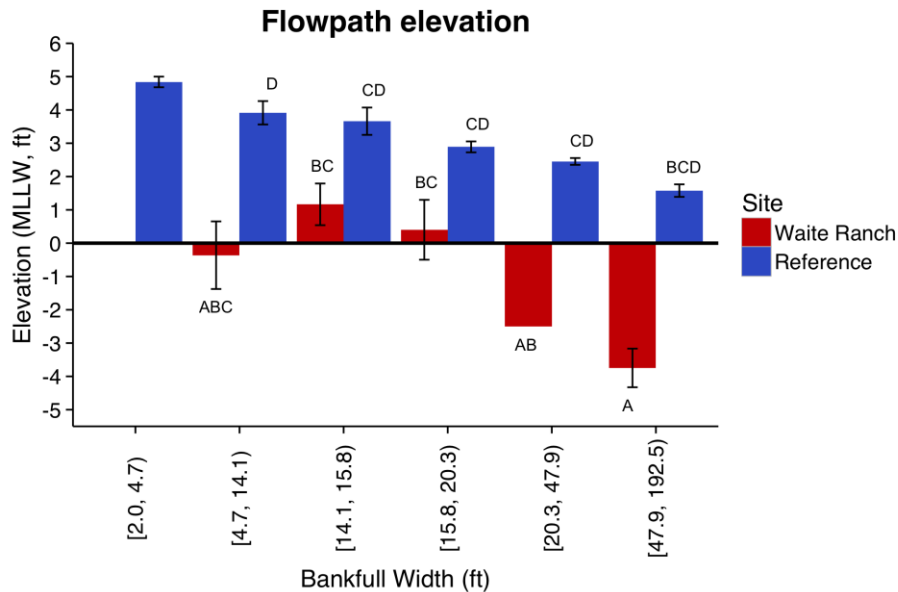
Figure A3.2. Flowpath elevation by BFW class for Waite Ranch and reference sites (Cox Island and S30). Bars with no letters in common are significantly different ($p < 0.05$). Error bars represent one standard error. The smallest channels (*i.e.*, “[2.0, 4.7)”) were excluded from the statistical analysis.
